Historic Structures Report

Benson's Property

Town of Hudson, New Hampshire

B&M Railroad Depot

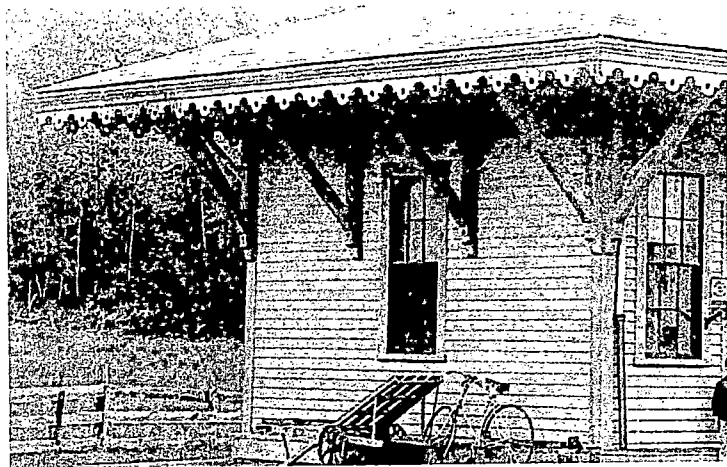
Exterior: Cornice and Gutter

The condition of the boxed gutters could not be determined with the existing tarp and asphalt roof. It is possible that they were covered over with asphalt shingles. The decorative eave boards have been removed, and the condition of the cornice moulding could not be determined. The leaders have also been removed, and the openings from the gutters patched in the board soffit. Examination from the attic interior showed that the existing flat eave boards have been damaged in some locations by rainwater intrusion and animals. It is anticipated that the overall condition of the gutters is poor. Restoration of the gutter and cornice features should take place in conjunction with the replacement of the roof after the building is moved to a permanent location.

Treatment Description: Repair wood soffit

Repair or replace in-kind missing or damaged 1"x 6" T&G wood soffit boards

Treatment Description: Fabricate and install decorative eave board
The size and layout of the decorative eave board can be determined from proportional analysis of the historic photographs to exactly reproduce the size and profile of the replacement. A custom millwork shop can fabricate the material from 7/8" Northeastern White Pine stock.

Treatment Description: Repair/replace wood boxed gutter and cornice
Repair or replace in-kind the wood base of the boxed gutter with kiln-dried, pressure treated lumber, and slope toward outlets. Carefully note and document evidence of cornice and gutter dimensions or profile using paint shadows, nailing patterns, or other architectural fabric information. Repair any deteriorated rafter ends prior to boxed gutter installation. Repair or replace cornice moldings as needed.

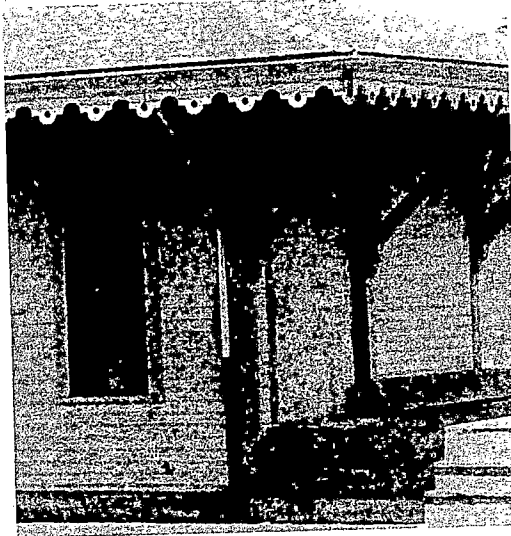
Exterior: Freight Door

The freight door, track, and hardware are missing. It is extremely likely that physical evidence to document the exact dimensions, location, and track configuration will be exposed when the non-historic interior finishes are removed. Combined with the documentary evidence contained in the historic photograph, it should be possible to accurately reproduce the freight door.

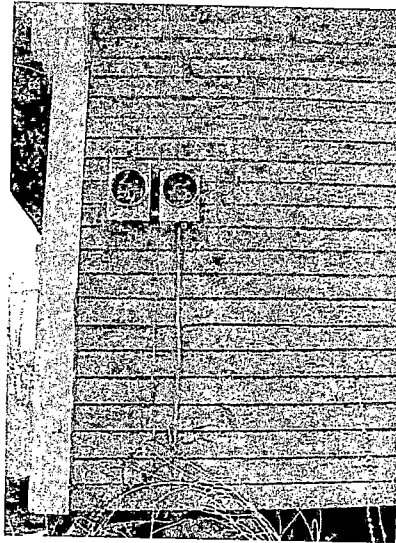
Exterior: Siding

The exterior of the Depot is sheathed with beveled clapboard siding at 5" exposure. Some replacement of siding is evident on the (site) southeast elevation below and adjacent to the door.

The clapboard siding is in generally good condition, except for paint failure. Some areas of siding replacement will be required if non historic window openings are infilled.

Treatment Description: Limited repair/replacement of existing siding

Match and install existing siding in-kind. Replace siding in-kind where non-historic opening locations are infilled.

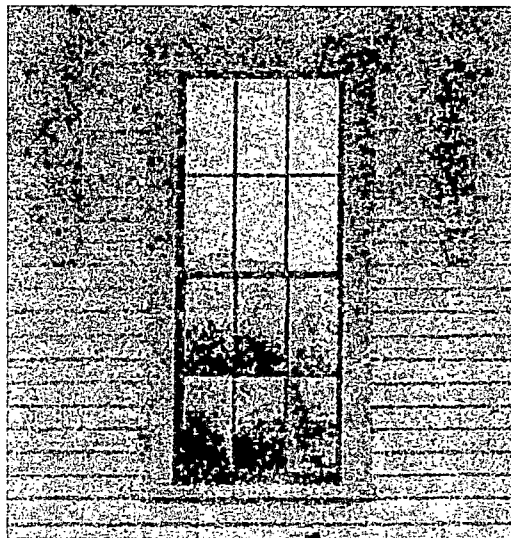
Exterior: Windows

Of the seven existing windows remaining in their original location, all are in extremely poor condition as a result of vandalism. The window sash are largely destroyed, and in several instances the frames have been heavily damaged as well. A non-historic window on the (site) northeast corner is in the location of a historic window opening.

Treatment Description: Reconstruct missing historic window

Reconstruct and install the missing historic window originally located in the (site) northeast corner of the building. Match the existing historic windows in materials, construction, joinery, and detailing.

Treatment Description: Repair historic windows in-kind

Salvage all existing window sash units and components including sash weights and hardware. Fabricate missing or damaged sections of stile, rails and muntins to match historic profiles using No. 1 Northeastern White Pine. Reassemble windows using the original joinery methods. Obtain salvaged or reproduction glass to match imperfections in the historic glass. Brush apply two coats of oil-based primer, such as California brand "Trouble Shooter" to window sash. Note: exterior trim painting covered in Exterior wood brackets and trim feature.

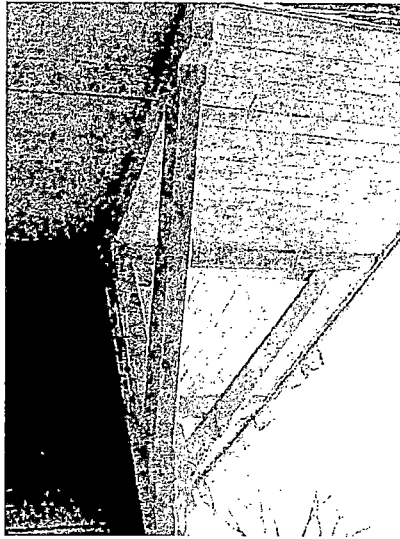
Exterior: Windows

The brackets are in good condition except for some paint failure.

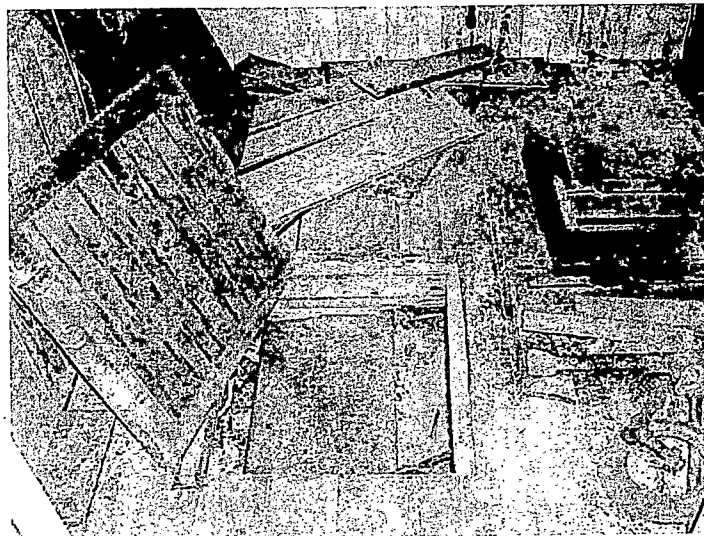
Interior: Floors

Where visible, the floor is in generally good condition. Some patching and repair will be required prior to refinishing.

Treatment Description: Repair/replace wood floor in Freight Room (25%)

Treatment Description: Patch and repair floor in public spaces (25%)

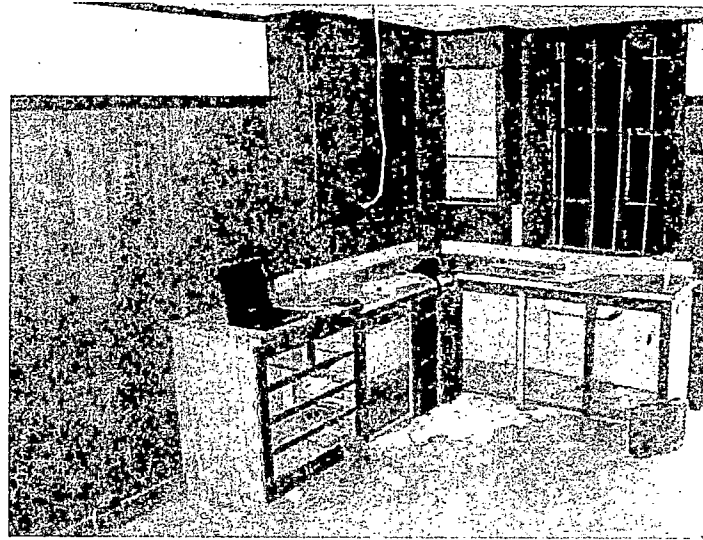
Interior: Selective Demolition

The interior feature, finishes, and fixtures dating from the use of the structure as a residence are in poor condition due to vandalism and neglect. Removal of these features is required for rehabilitation of the building.

Remove non-historic interior partitions in the Freight Room area. This work should be done under the supervision of a preservation specialist to prevent damage to historic features, materials, and finishes to remain.

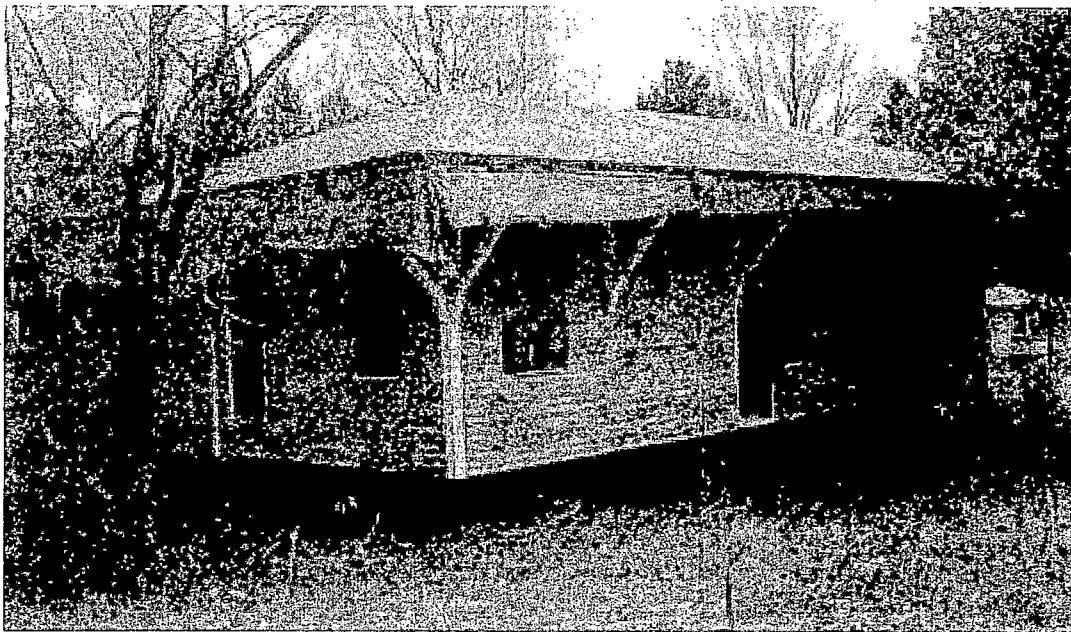
Figure 9. Existing condition of B&M Railroad Depot. Photograph by Lisa Sasser. (April, 2003)
