Historic Structures Report

Benson's Property
Town of Hudson, New Hampshire
May 22, 2003 – 100% Submittal

Haselton Barn Feature Inventory and Condition Assessment

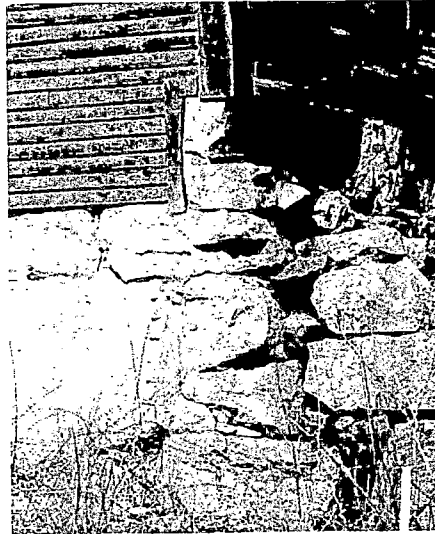
Foundation: Main Barn

The foundation needs considerable repair along the south eave perimeter wall. The retaining walls perpendicular to the foundation also need to be realigned. Drainage along the south eave of the building is poor, allowing water to enter the foundation and push it apart during the freeze/thaw cycle.

The stone foundation along the south eave will need to be cataloged and dismantled down to where the foundation is solid. The estimate includes removal to a depth of six feet if necessary. The foundation should be dry laid and reset with the original stones to provide a solid foundation. The installation of proper drainage along this wall will ensure the longevity of the wall.

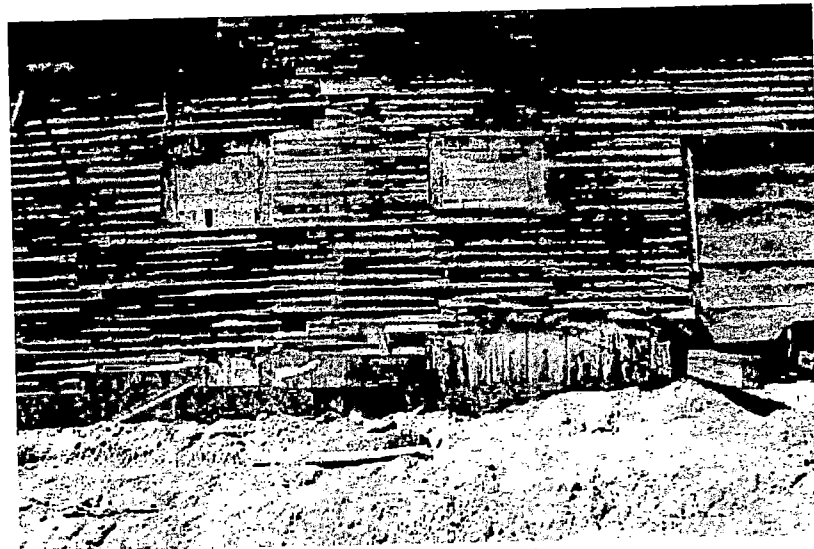
Sills: Main Barn

Sills along the north eave wall of the barn appear in very good shape as they are well above grade. Sills along the West gable end also appear in good shape albeit they are part of the two added bays of the barn. They too are well above grade. Sills along the south eave wall have been damaged by water and will need repair. The sill along the east gable end is damaged due to high grade and water penetration. Temporary supports have been added to the drive sills and adjacent drive joists where the joinery has rotted as they engage the rotten gable end sill.

As much of the original sills should be retained as is possible to assure the structural integrity of the frame. Where replacement is necessary, new hemlock beams of equal size and conversion method should be utilized. This means that if part of an original sill is rotted at one end, then the new wood used to repair the end should be of the same size and similar species. Although most of the sills appear to be pine, replacement wood should be native hemlock as it is more rot resistant. All new wood spliced to old should utilize the bladed scarf joint that appears throughout the building. Wooden pegs should be installed to secure any joinery. All joist pockets, post and stud mortises should be installed to match the layout of the original sills.

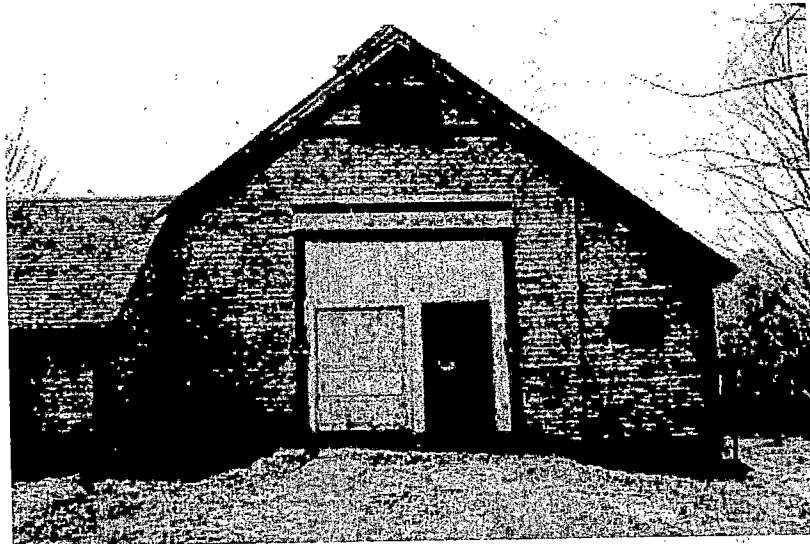
Main Barn: Bent One - East Gable End

Condition Rating:
Poor

The existing pine clapboards are in pretty good shape but some repair and replacement is necessary. New clapboards should be radially sawn pine clapboards primed on all sides with a high quality oil base primer. 5d stainless steel ring shank nails should be used for fastening the clapboards.

The original pocket door and hardware remain intact behind the current modern doors and plywood. The modern materials should be removed and the pocket door repaired using in-kind materials and methods. The hardware can be refurbished to allow for ease of operation. Any missing hardware can be reproduced in kind.

The original window opening in the peak of the gable end remains. A new sash could be acquired and the frame repaired or a new window unit could be installed. The window should match the evidence found in photographs and other physical evidence that provide the basis for its reproduction.

The original transom light opening over the original door opening is partially intact. Carefull investigation of the opening can determine the size and construction of the original transom light and frame for its repair and reproduction.

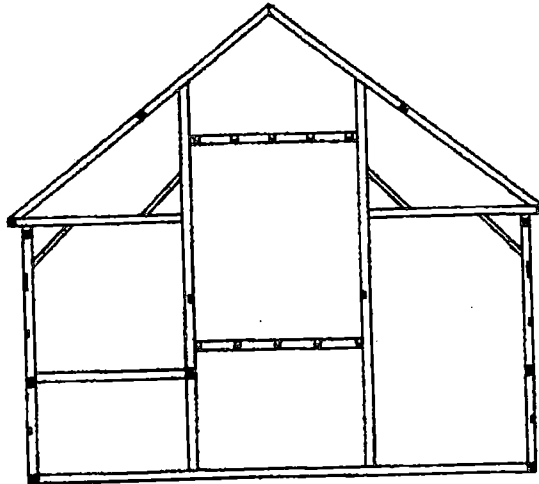
Main Barn: Bent Three

Bent three shows signs of tension failure across its tie beam/post connections. Some work has been done to minimize the spreading of the joinery in the form of a steel cable that is through bolted through the perimeter posts. The cable is placed just below the discontinuous tie beams in the loft level of the frame. The through bolts are close to the discontinuous plate mortises thus reducing the strength of the tops of the perimeter posts.

The design of the barn with the discontinuous tie beams connecting the perimeter walls with the drive posts leaves a minor structural challenge. When the building settled this joinery connection was placed under considerable stress. It is here that the frame design is at its weakest. The tenon on the end of the tie beam is not strong enough to withstand the roof load outward thrust following foundation settlement and or failure. This pulls the joinery apart and reduces the strength of the frame. One method of correcting this is to add a wrought iron strap no more than two to three inches wide around the post and the tie beam connection and fasten the U-shaped strap to the tie beam with through bolts. The strap should extend into the field of the tie about two feet to allow for three bolt connections. The use of such straps is common in larger buildings and many barns of similar age. The through bolts would have square heads and nuts to match the period of construction.
