Haselton Barn

Benson Park, Hudson, NH

Updating of 2003 Historic Structures Report with Preservation
Strategies for the Town of Hudson, NH
September 25, 2018

Bedard Preservation & Restoration LLC
PO Box 430
Gilmanton, NH 03237

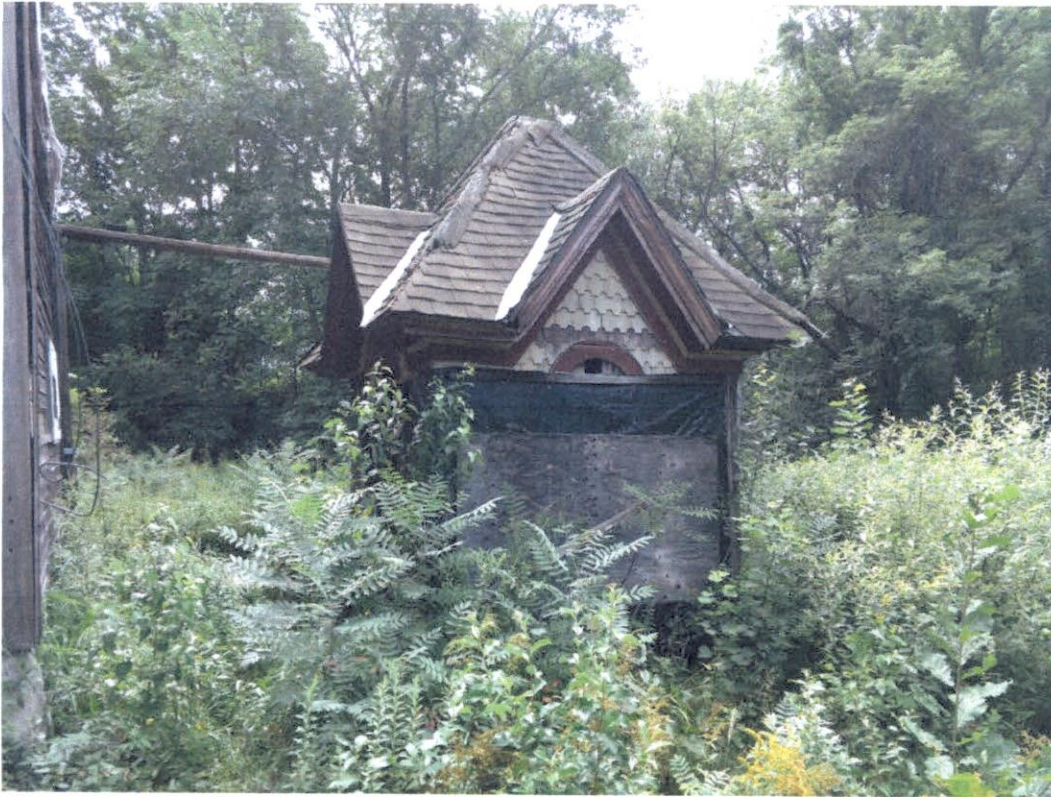
Cupola

The cupola was successfully removed from the barn and then the hole in the roof was patched. Structural repairs were also made to the roof framing. While the cupola was placed on bunks to try to protect it from ground moisture, a temporary roof was not built over it or the cupola was not moved to dry storage.

The cupola therefore continues to show significant deterioration since the 2003 report.

The Cupola now rests on the ground behind the barn. A temporary frame with roof structure should be built over it to protect it from the elements.

Cost \$ 1,400

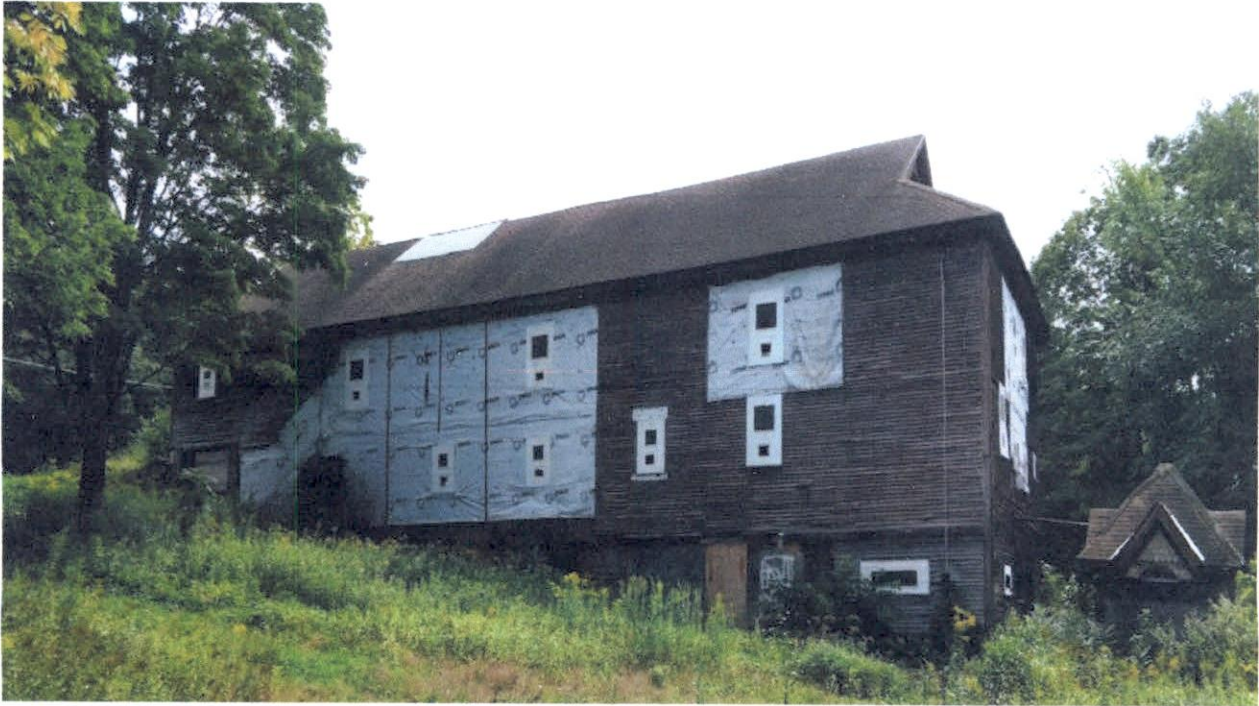
North side of building showing re-shingled asphalt roof and Typar house wrap to cover areas where clapboards have been removed

Unfortunately, the house wrap should only be exposed to the elements for a maximum of six months. After all these years later, the house wrap has deteriorated to the point that it provides very little if any at all protection of the barn sheathing/framing underneath it.

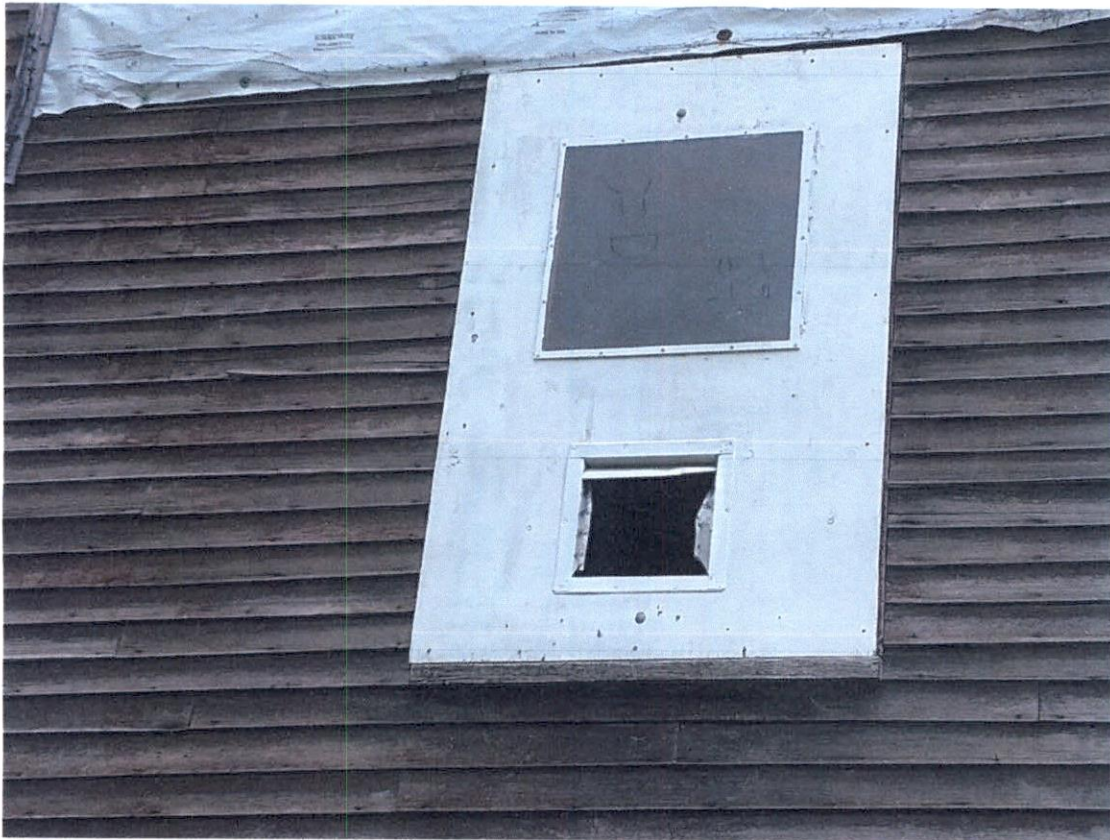
The use of plywood, Plexiglas panels and vents did not work due to the fact that the Plexiglas panels and especially the vents could be kicked-out by vandals.

Plywood with Plexiglas and ventilation grill that fills the window opening and has been kicked-out by vandals

Openings where wall vents have been removed should be replaced with heavier louvered vents. The inside of the window openings should then receive a cover of expanded diamond steel (a minimum of 1/4" thick 18 gauge). This material should be installed with large "square drive" screws as the "bit" is unusual. Do not use "Philips drive" screws. The floor hatch between the first floor and the basement should also receive an expanded metal cover, fastened appropriately.

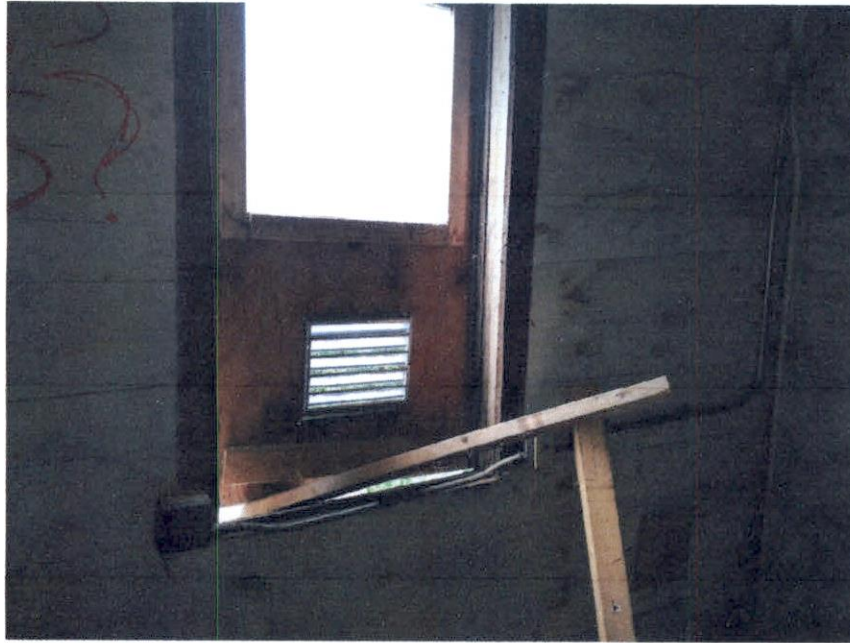
Use of debris lumber to start to pry open plywood window unit

The idea of prying out this window was to gain access to the outside and connect to a wooden plank that was placed on the roof of the cupola.

Clean out all debris (including wood) from the building

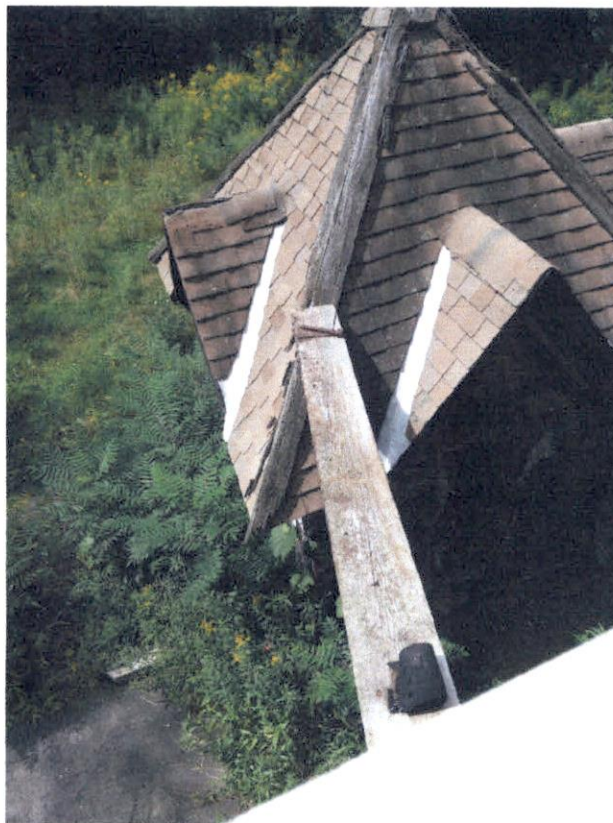
A wooden plank leading from the attempted breach of the window opening to the roof of the cupola

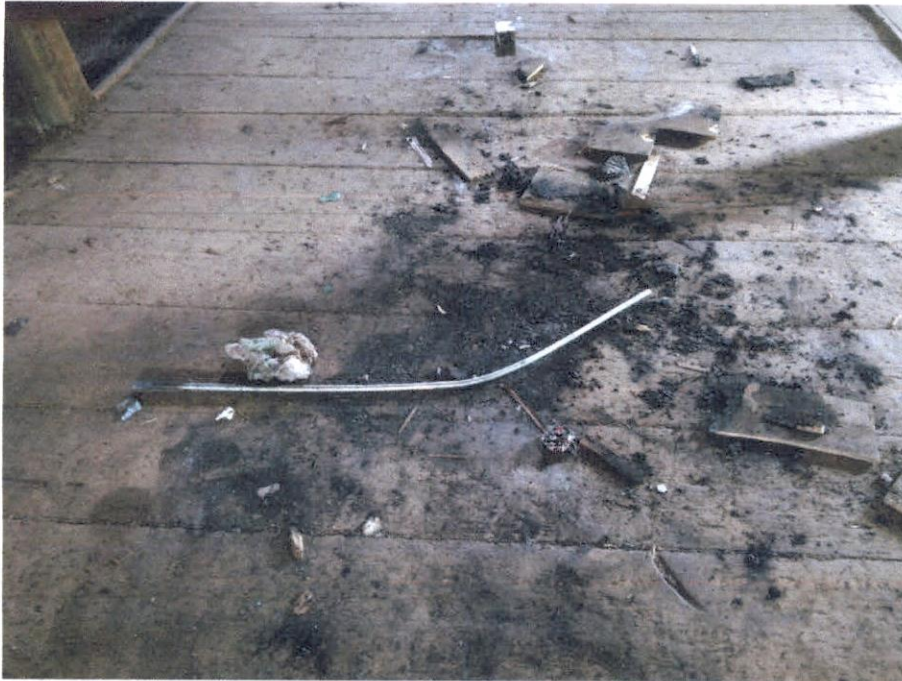
Apparently sometime after 2003, a small fire was started by vandals on the main floor of the barn. Fortunately, it did not spread any further.

Charring from a small fire built on the wooden floor of the barn

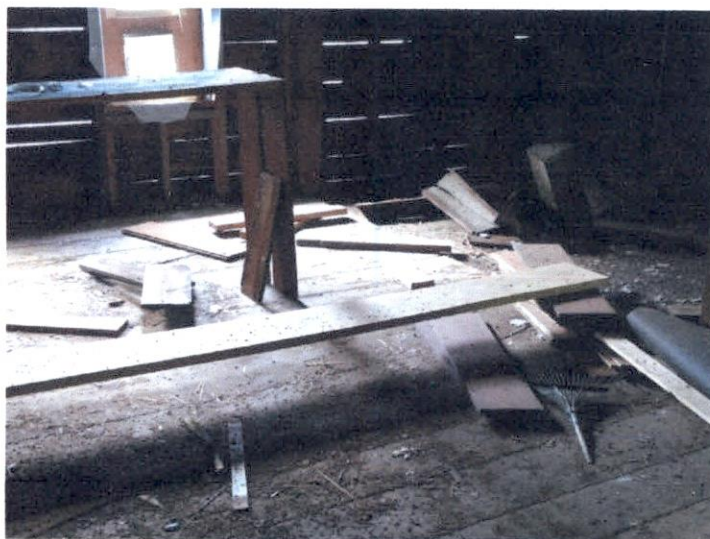
Remaining debris allows for material to be used as tools to cause damage as well as fuel for fires

Debris inside of barn

Cost \$ 800.00

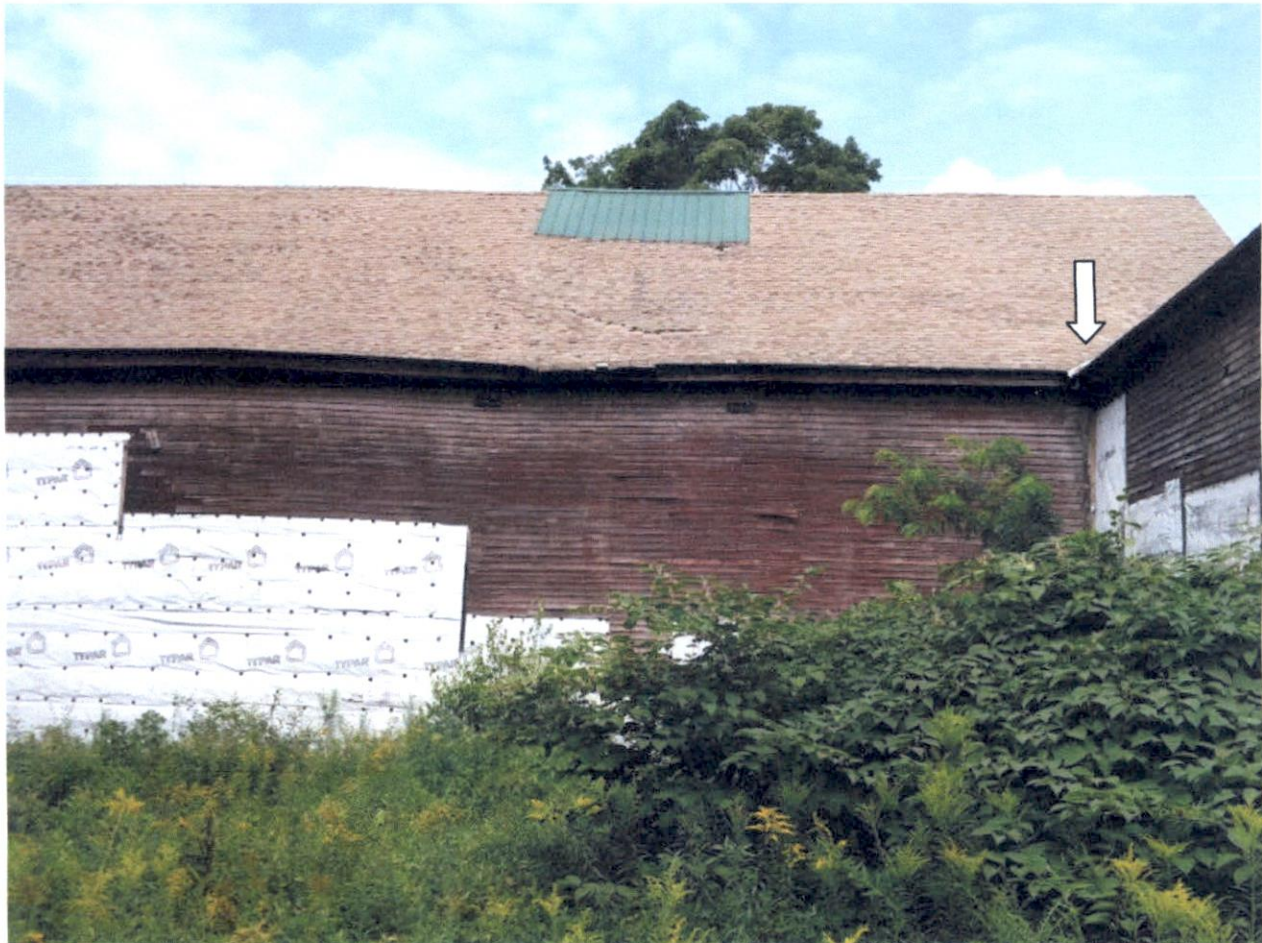
The asphalt roof on the southern side of the main barn and the back side of the granary are in poor condition and shows signs of leaking in a few places such as in the valley between the main barn and granary.

South side of main barn roof with granary attached to far right.
The white arrow shows the location of the leaking valley

The repair of the sagging roof area should be done in conjunction with the replacement of the shingles on the south side of the barn/west side of the granary.

Re-roofing of south roof and one side of granary (this includes stripping of the existing roof, minor repairs to sheathing and re-shingling the roof with 30 year architectural asphalt shingles)

Re-roof \$ 22,000-\$ 27,000

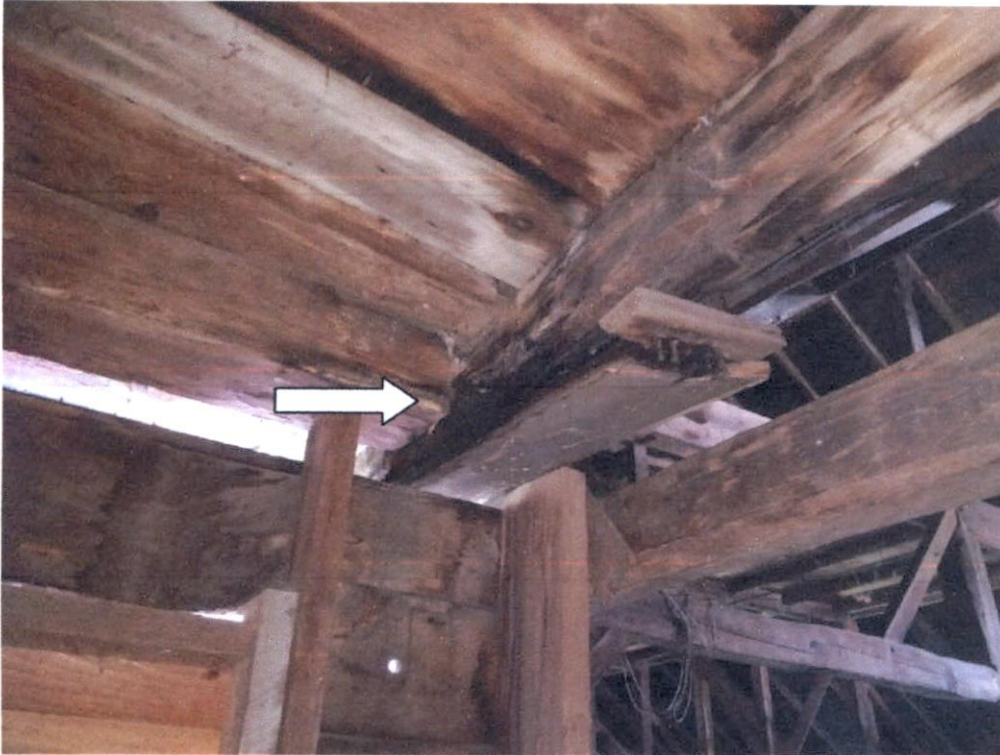
Inside the barn where the granary attaches to the main barn, one can see the leaking valley and the damage it has caused over the years.

The white arrow indicates the area of rot, repair and continued leaking

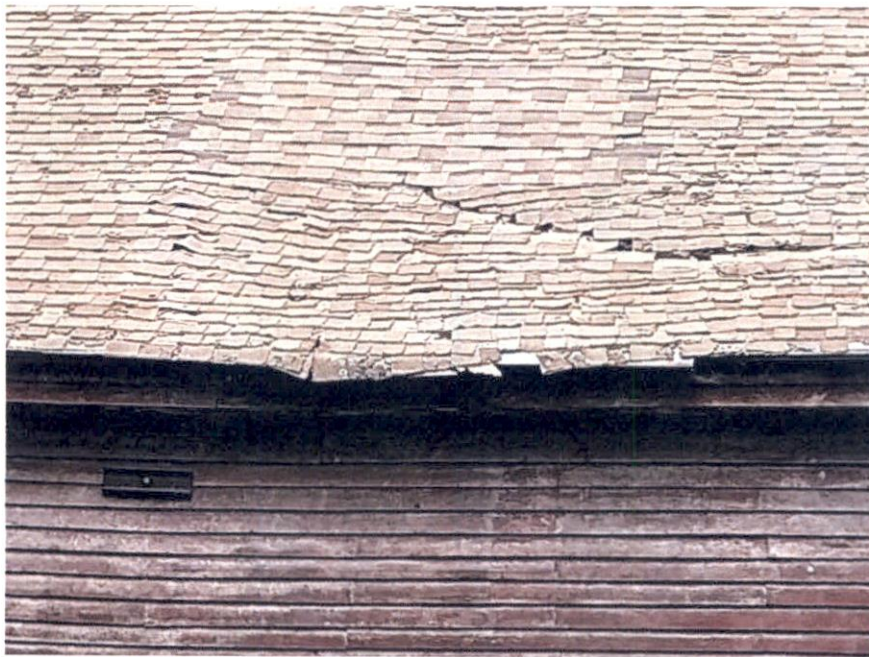
In the close-up of the south roof of the main barn, it appears that the shingles are actually beginning to slide-off of the roof itself. This damage would typically be caused by a roof sheathing failure but in this case it may be caused by settling concerning a rotted sill where the post above it settles along with the top plate, rafter and sheathing.

Section of the failing asphalt shingles on south side roof of the main barn

Repair of sagging area \$ 6,500- \$ 8,500 (while this range would be enough to cover the repair, it could actually be considerable less but will not be able to be determined until that area is opened-up)

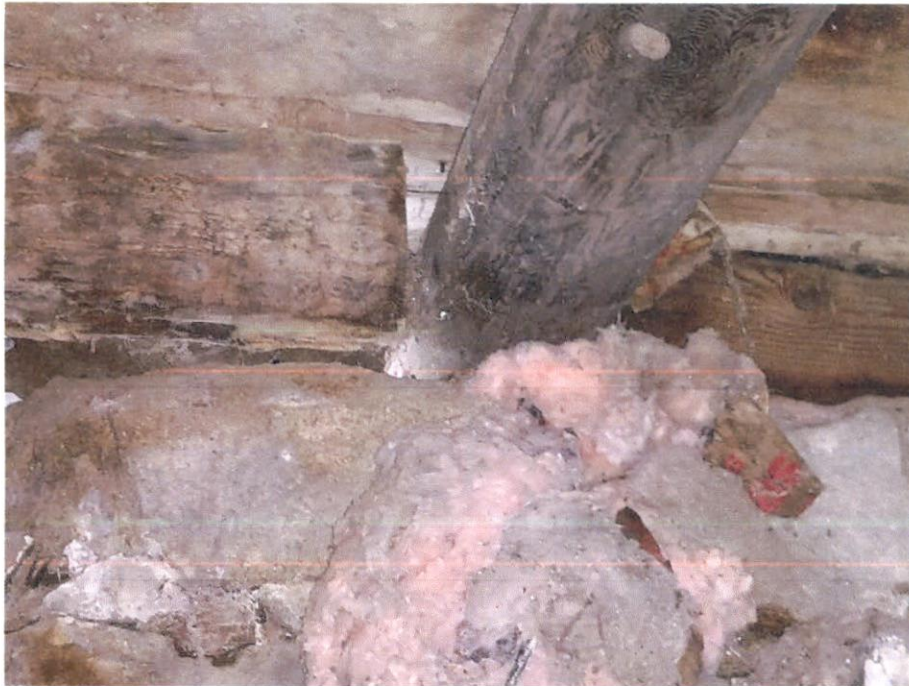
Inappropriate sill repair and replacement floor joist, south side

This area in the basement is the section where the sill and floor joists connecting to the sill were inappropriately replaced. In this particular section, a whole piece of the sill has been cut out. A new floor joist made out of a telephone pole has been installed in the cut-out sill space. This could be the source of the roof sagging (failure).
