## Historic Structures Report

Benson's Property  
Town of Hudson, New Hampshire  
June 16, 2003 – 100% Submittal

## Benson's Office and Kitchen

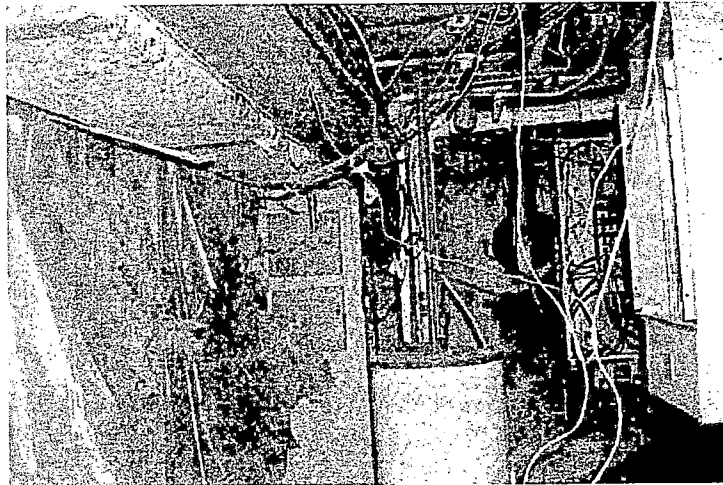
*Building Interior*

The interior of the Office was originally one undivided space with a high open ceiling. It has since been subdivided into three rooms with the addition of a full height partition wall to create a bathroom and another small room on the north end of the building. The space above the 8' ceiling of the new rooms is an unfinished loft space accessed by a hatch in the bathroom ceiling. The large room has built in cabinets along most of the length of the east wall. Floors are carpeted. The ceiling of the large room has been finished with v-groove T&G siding to conceal the unpeeled log rafters and rustic, rough sawn board roof sheathing. Four 6"x 8" rough sawn beams span the width of the room at rafter plate height. These beams appear to have been added at the same time the ceiling was cased in. The top surfaces of the beams have small wooden dowels set into their top surfaces at regular intervals, with smaller diameter dowels let into the verticals, running the length of the beams. The function of the dowels is uncertain. The gable roofed dormer is completely blocked by the ceiling paneling, and the shed roofed dormer is concealed in the loft space above the dropped ceiling. Some fixtures remain including a ceiling fan and track lighting in the large room.

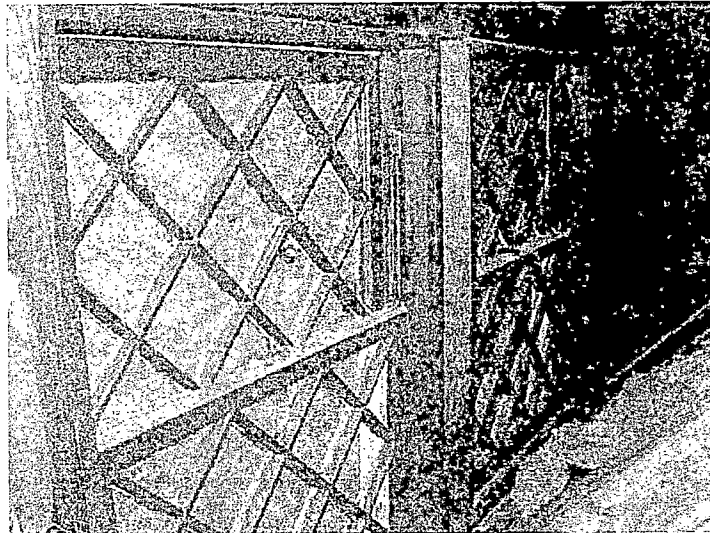
*Exterior Openings: Windows*

The Office contains a mix of fixed, casement, and double-hung wood sash windows. The west façade contains a pair of large fixed 24-lite wood windows, each approximately 5'- 8" x 4'- 8", and one 6-lite, single-hung window in what is presently the bathroom. This window may have served as a cashier's window for the office since there is an 8" wide shelf at the base of the window on the building exterior.

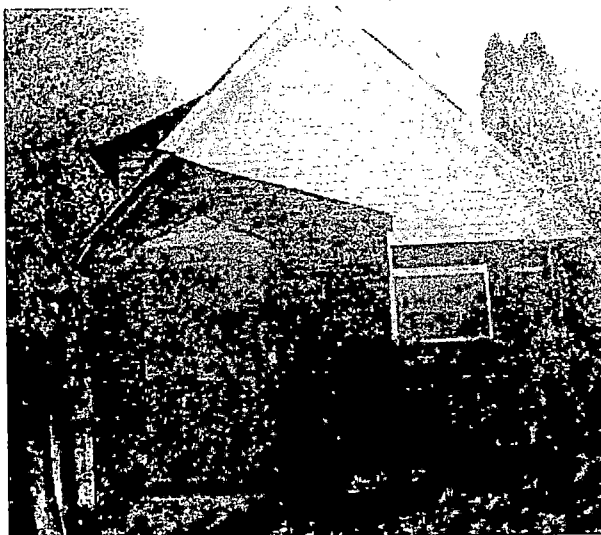
*Exterior: Clapboard Siding*

The North elevation is covered with tongue & groove double Clapboards. Tine lumber planed 4 sides with tongue and groove edges with two bevels on one side giving the appearance of two rows of clapboards. For use as exterior siding.

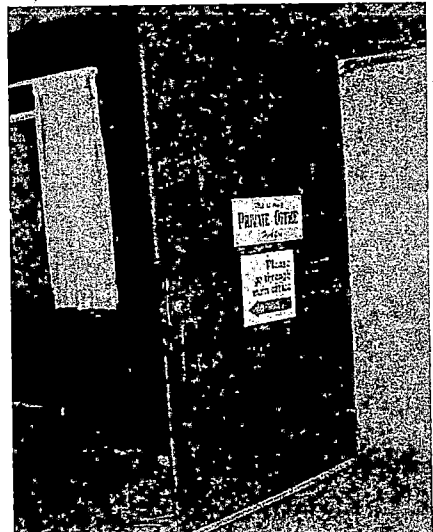
*Exterior: Doors*

Of the three first floor doors to the Office, only one the one on the west elevation is presently operable. The east elevation door opened on to a deck which no longer exists. Two original entrances are placed opposite each other on the east and west walls. A boarded up door located on the north elevation formerly accessed the First Aid building. This door location appears to be original to the construction of the building. A cutout in the clapboard sheathing above the door indicates that there was originally a small projected gable roof sheltering the door. The basement had one exterior door in the masonry foundation wall at the southeast corner of the building. The passageway between the Office and Kitchen had a single door opening in the masonry wall of the south elevation west of the chimney.

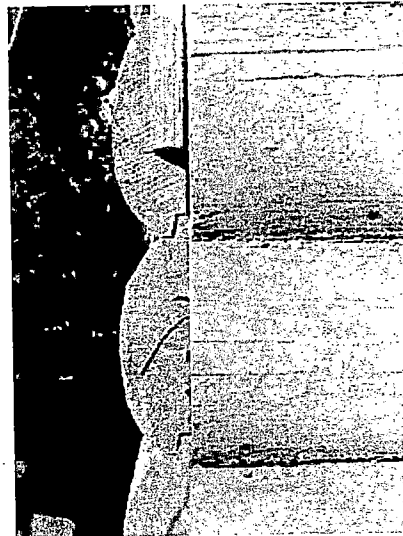
*Exterior: Novelty Log Siding*

The west and south elevations of the Benson's office are covered with 2"x 6" (5-inch exp.) Northern White Cedar, D-log siding. The log siding is original to the construction of the Benson's office, and is a significant character-defining feature, giving the building much of its rustic character. The corner joints are covered with 3/4" quarter round moulding.

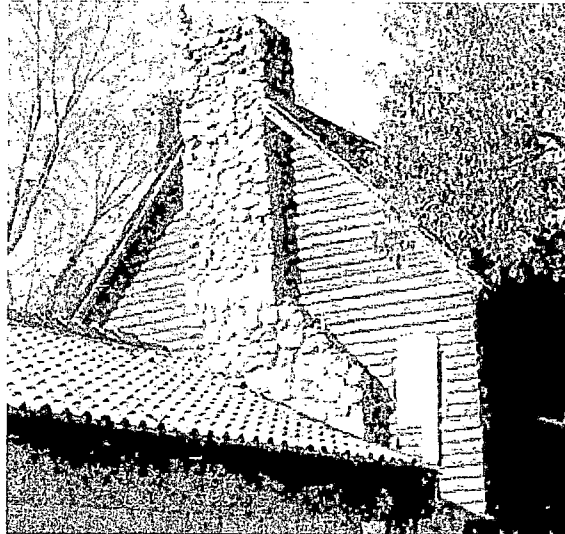
*Exterior: Stone Chimney*

The chimney is constructed of random rubble field stone, laid up in gray Portland cement mortar. It is original to the construction of the Office Building and is a significant character-defining feature. The chimney is constructed on a concrete foundation.

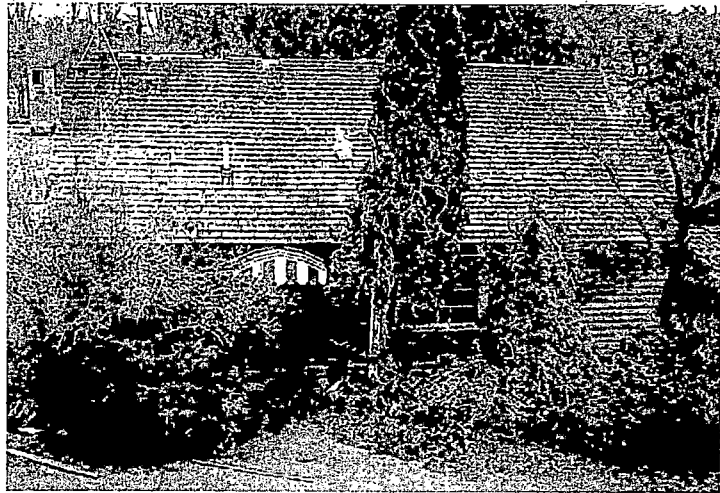
*Exterior: Wood Shingle Roof*

The roof of the Benson's Office is covered with cedar shingles at 5-1/2" exposure. Wood shingles are original to the construction of the Office. It has not been determined if this is the original roof. The wood shingled roof contributes significantly to the architectural character of the Office, and should be replaced in-kind.

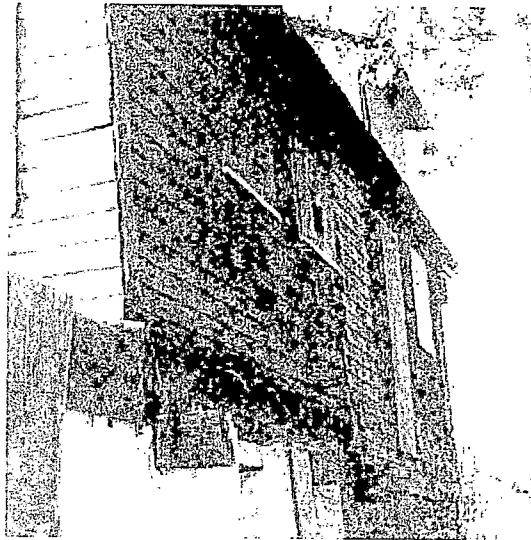
*Exterior: Wood Shingle Siding*

The east elevation is covered with red cedar shingles at 5" exposure. Patching has taken place adjacent to, and below the door, probably to cover a former stair location. Metal flashing and roof tar define the former deck location. The corners are covered with 1"x4" boards.

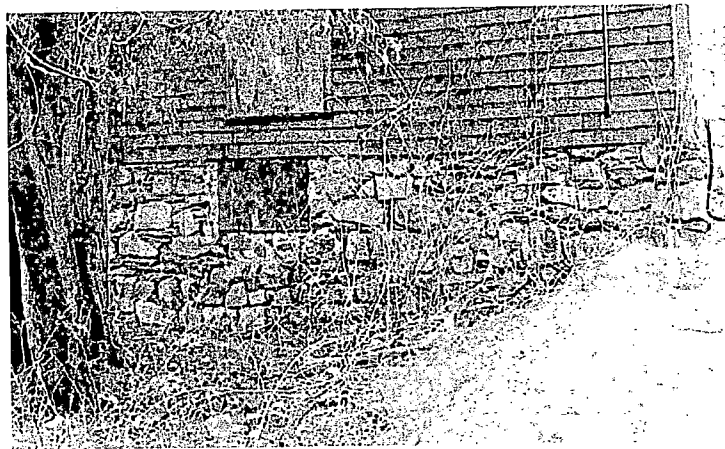
**Foundation: Stone**

The building is located on a steeply pitched site, sloping from the northwest to southeast corner, exposing the fully height of the stone foundation wall along much of the east elevation. The random rubble stone wall is laid on a poured concrete footing. In the northwest corner of the structure the footing is poured against granite ledge, which appears within the basement. The basement has a full concrete floor slab.

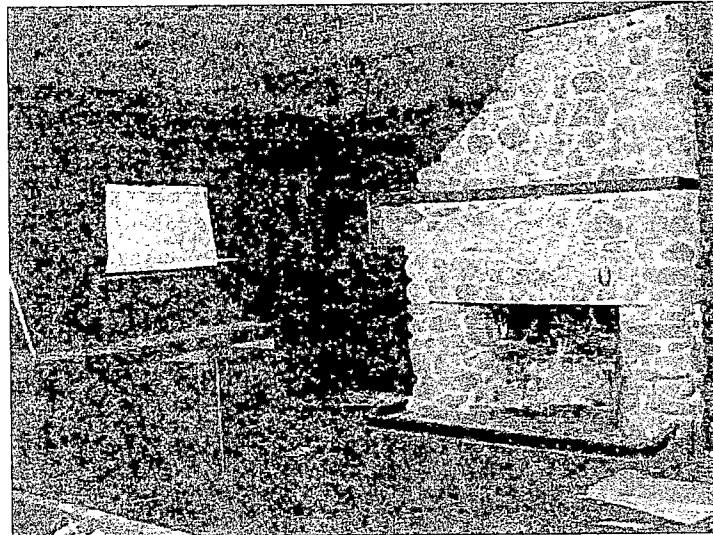
*Interior Finishes*

All of the original finish materials of the original Office remain intact under the applied finishes and additions. The first floor of the Office consisted of one large undivided space with an open ceiling and D-log wall paneling. The stone chimney is the principal interior feature of the space.

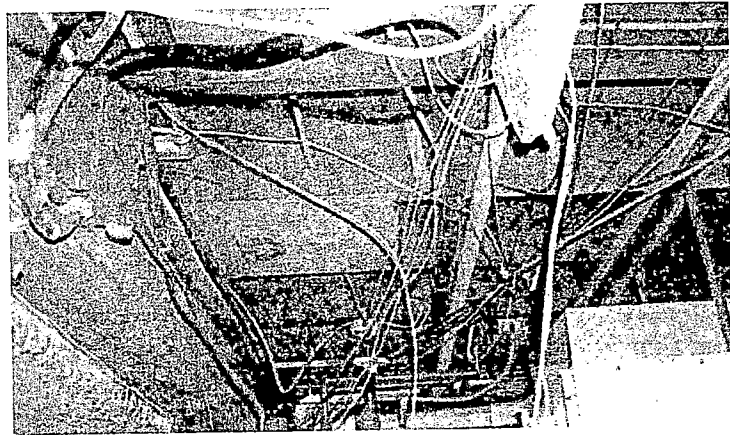
**Structure: Floor Framing**

Where visible in the north third of the cellar, the floors are framed with 2"x 8"s on 24 inch centers running north to south. Four large dimension (10" x 10" or 8" x 12") beams span the cellar east to west, and carry the floor joists. Three of the beams originally projected beyond the east wall to carry a wood framed deck at the location of the east elevation first floor door. No documentation has been located on the appearance of the deck with the exception of framing members on the south elevation where the connecting passage between the Office and Kitchen is now located. A remnant concrete footing is located 8'- 0" beyond the face of the building, which probably was the edge of the paved porch below the deck.

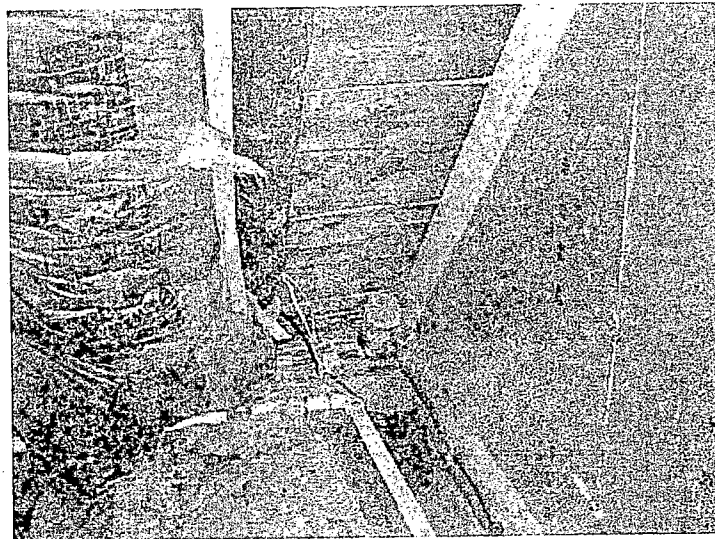
*Structure: Roof Framing*

The Office roof is framed with unpeeled pine logs on 24" centers. The logs are flattened on the top bearing surface for an effective depth of approximately 5". The rafters are paired with no ridge. The log rafters are sistered with new 2"x 4"s. The roof is sheathed with 1"x 10" rough sawn boards with waney (bark on) edges. The north gable wall has a 1/2 log trim piece at rafter plate height. The log rafters and roof sheathing were designed to be visible. V-notch tongue and groove paneling was installed as a finish ceiling in the south room. In the attic space created by construction of the partition wall, fiberglass insulation was added, concealing the roof sheathing and rafters. At the corners of the north elevation wall, the rafters are cut off as exterior decorative elements only.

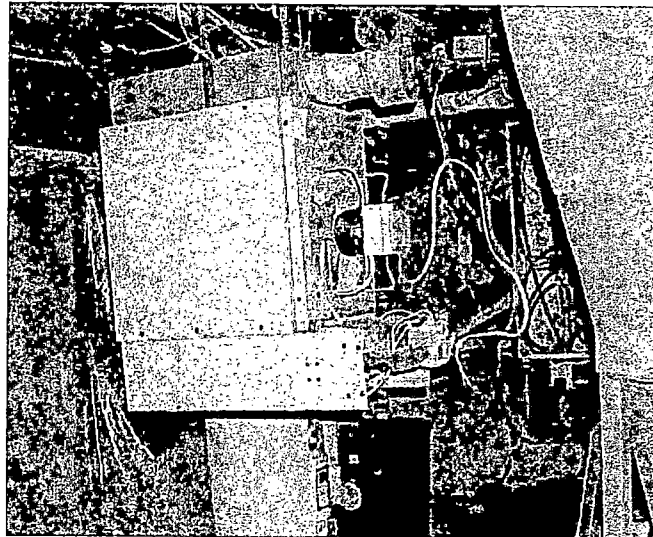
*Utilities: Mechanical, Electrical, and Power*

Existing mechanical, electrical, and power features in the office are an ad hoc collection of parts and systems, many of which do not meet code. 200 amp/240 Volt electrical service enters the cellar below grade through a window in the north wall and a cast-in-place service chase in the west wall. Water lines also enter through the west wall service chase. An electrical panel and shut off are mounted on the cellar walls. Panels for phones and security systems are also located in the north room of the cellar. Another electrical panel containing fuses marked "Arthur's office" and "walk in cooler" is located on the north wall of the south room of the cellar. A gas-fired furnace and system of ducts provide hot air to registers in the first floor of the building. A gas fired unit heater is suspended from the attic floor framing, in a location that does not meet code required clearances. The condenser unit for the walk in cooler remains in place in the cellar interior. A 49 gallon water heater and 115 Volt sewage/sump pump complete the building MEP systems.

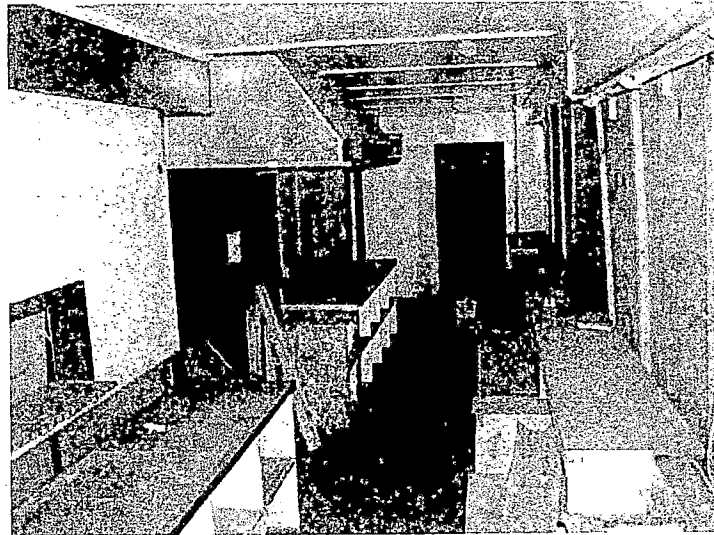
*Building Interior*

The Kitchen interior is configured for the food service operation of the Arthur Provencher period. All interior finishes, fixtures, and appliance are post-1950.

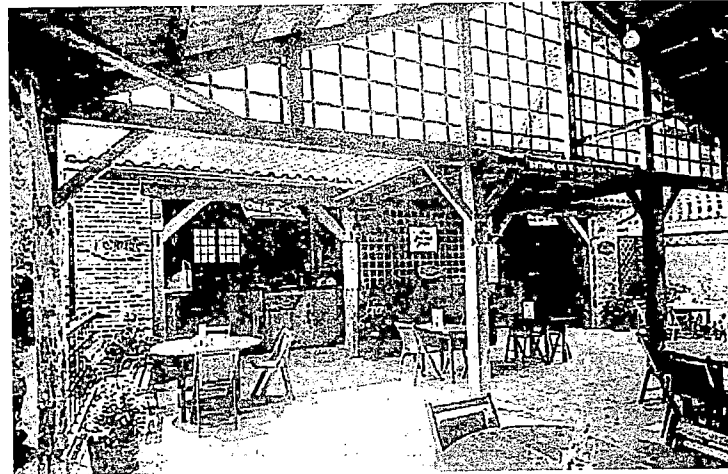
*Exterior Opening: East Elevation*

As originally designed the entire east wall of the Kitchen was open to the seating area of the timber framed pavilion which served as the Bavarian Beer Garden. The Beer Garden was 48' long by 36' wide with the gable roof oriented perpendicular to the Kitchen. As shown in the photograph opposite, the Beer Garden was originally open sided. The 1992 NHDHR photographs taken prior to demolition of the Beer Garden show that the walls were later fully enclosed.

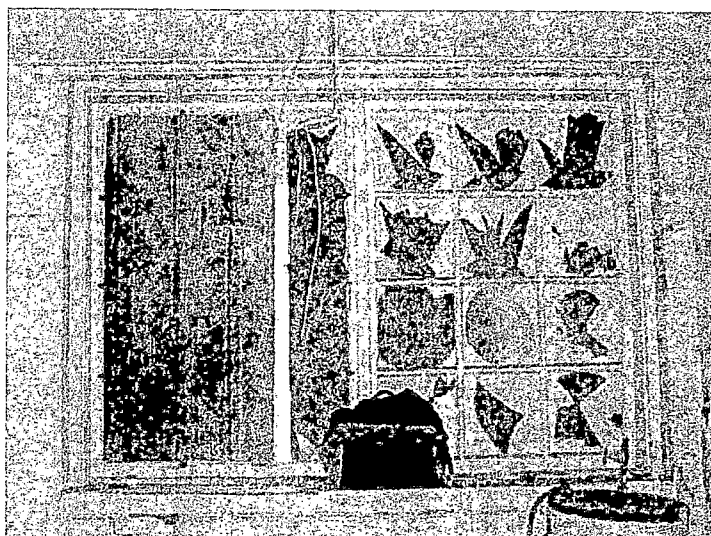
*Exterior Openings: Windows*

The Kitchen has four window opening. Two windows are spaced evenly on the west elevation, at grade level. The openings are 4'- 0" wide x 42" high, and contain a pair of 12-lite wood casement sash. There are two windows on the south gable end of the building flanking the chimney. The window to the right of the chimney is the larger of the two with an opening of 6'- 2" x 5' -6". It is closed on both the inside and outside with painted plywood. The window to the left of the chimney has an opening size of 6'- 6" x 4'- 8" with 2 wood, 12-lite casement sash. The 1992 NHDHR photographs show both window openings enclosed with painted plywood, apparently installed during the operational period of the Bavarian Beer Garden to close off the view of the food preparation area. The window to the east of the chimney is not accessible, but is assumed to also contain a pair of wood casement sash.

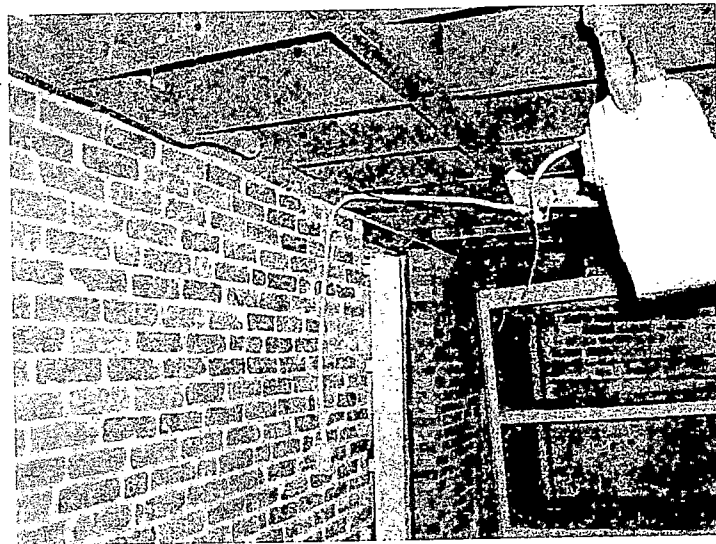
*Foundation Wall: Brick*

The brick walls of the Kitchen and connecting passage are 12-inch, 3-wythe brick laid in common bond on a concrete footing. The site is pitched from west to east, with the west wall functioning as a retaining wall, sloping to grade level on the east side. On the west elevation a concrete stem wall is poured to approximately the level of the exterior grade. There is a 24" square chimney on the south elevation. The north and south elevations of the brick wall are continuous up to the gable ridge. On the north elevation, a dimension lumber ledger is lagged into the brick to carry the framing for the roof of the connecting passage.

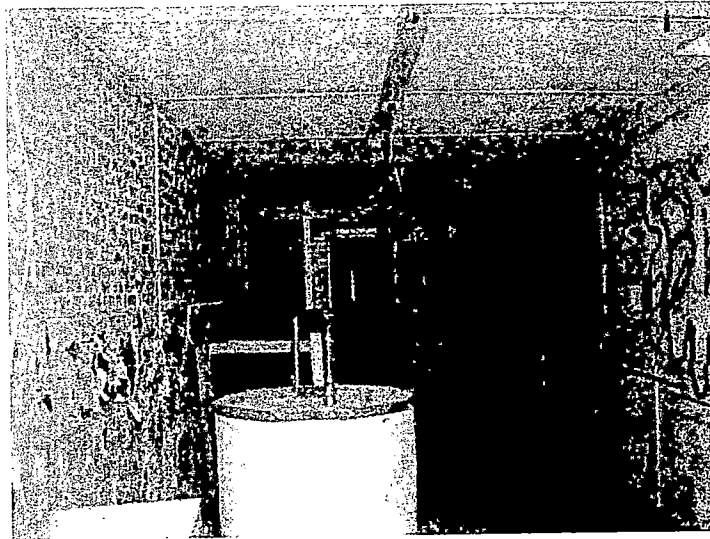
*Interior: Finishes*

All interior finish surfaces including brick and concrete walls, wood roof sheathing and the roof structure were originally painted. The earliest color layer on the brick walls is red. The roof framing and sheathing shows the original yellow paint color in the attic space.

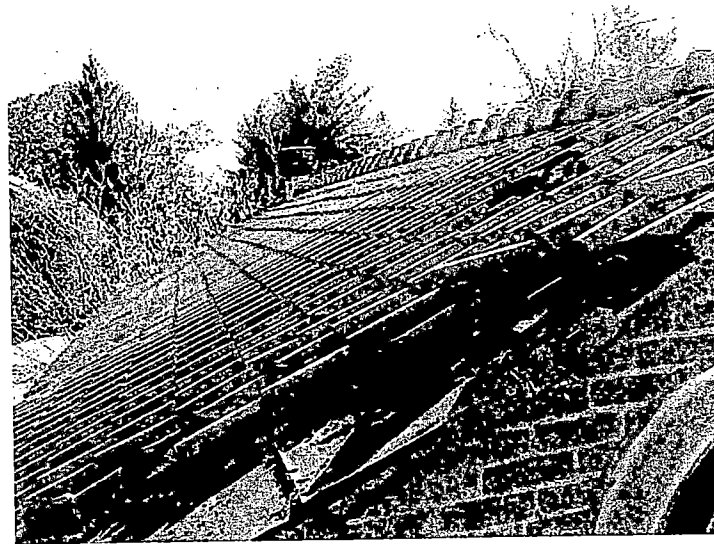
*Roof: Clay Tile Roof*

The tile roof is an original feature of the Kitchen, and is one of the most significant character-defining features of the structure. The roof tiles are fabricated by the Ludowici Roof Tile Company of New Lexington, OH, which has been in continuous production in the United States since 1888. Ludowici tile roofs are a feature of many important historic buildings including those at Ellis Island. The roof is made up of 13-1/4" x 9-3/4" Spanish tiles with a 10" exposure. Tile fittings include the distinctive ribbed ridge units, left and right-handed detached gable rakes, and top and eave-closure fittings.

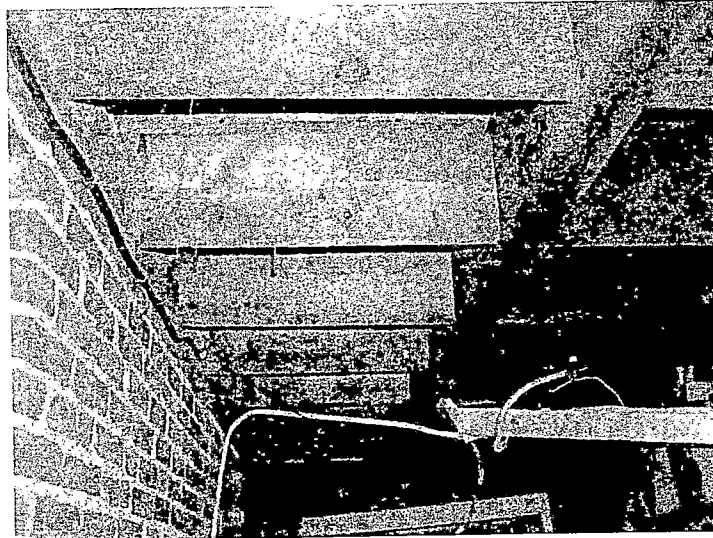
**Structure: Connecting Passage Roof**

The covered passageway connecting the basement of the Office with the Kitchen is not original. The framing of the passageway roof indicates that the Office originally had an elevated walkway entered at grade from the southwest corner which continued around to the east elevation of the Office as a raised deck. The architectural evidence does not indicate whether the Office or Kitchen was built first, although both structures are believed to have been constructed c.1930. The brick wall at the west end of the passage appears to be a later infill. There is no wall on the east elevation of the passage.

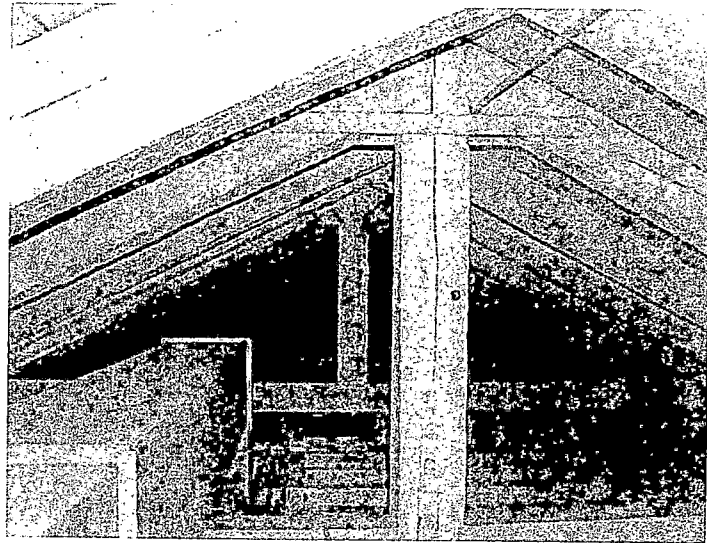
*Structure: Roof Framing*

The Kitchen roof structure is the most significant character-defining feature of the original interior space. Although concealed by a later dropped ceiling, it was originally open to view, and was designed to be seen as part of the rustic appeal of the Bavarian Beer Garden, when it functioned as a food service area. Installation of the ceiling and interior partition took place after changes in the food service operation post-1950.

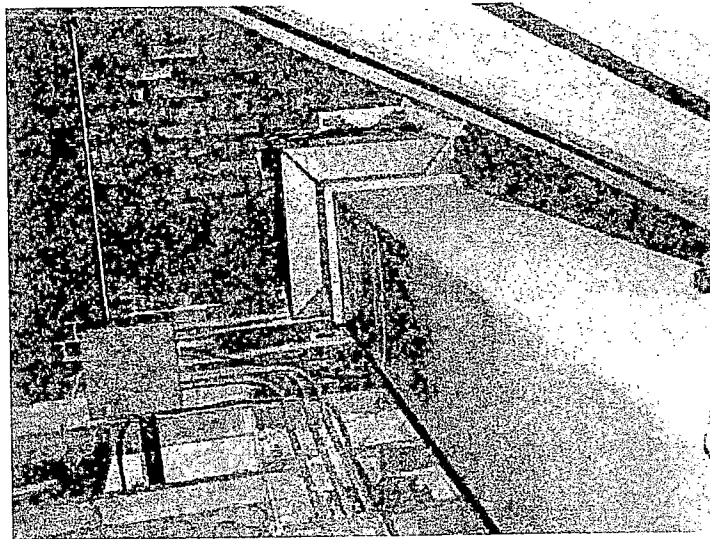
*Utilities: Mechanical, Electrical, and Power*

Electrical service enters the Kitchen below exterior grade through the wall in the northwest corner. There is a large electrical panel on the interior of the north wall of the kitchen and a distribution box in the attic space above. A large exhaust fan and ductwork in the attic space served a commercial exhaust hood above the grilling station in the food service area.

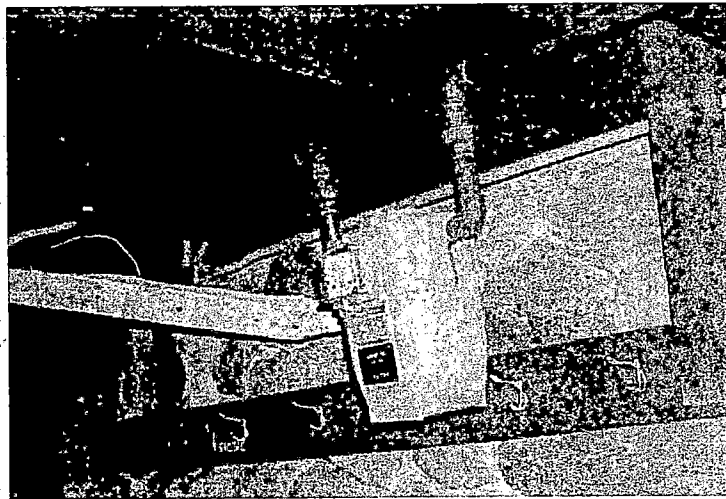
*Site: Utilities*

The Office and Kitchen continued in use until 1987, and was fully connected to public utility services including water, sewer, electricity, telephone, and natural gas. Rehabilitation of the Office and Kitchen for contemporary uses will require verification of the location and condition of public utility hookups. The underground electrical power feed and water line to the Office enters through a metal pipe in the northwest corner of the cellar wall. A second electrical power feed enters through the north elevation cellar window. The Kitchen electrical power feed enters below grade in the northwest corner through the brick foundation wall. A natural gas meter is located in the connecting passage between the Office and Kitchen. The water supply line to the Kitchen is routed from the Office cellar.

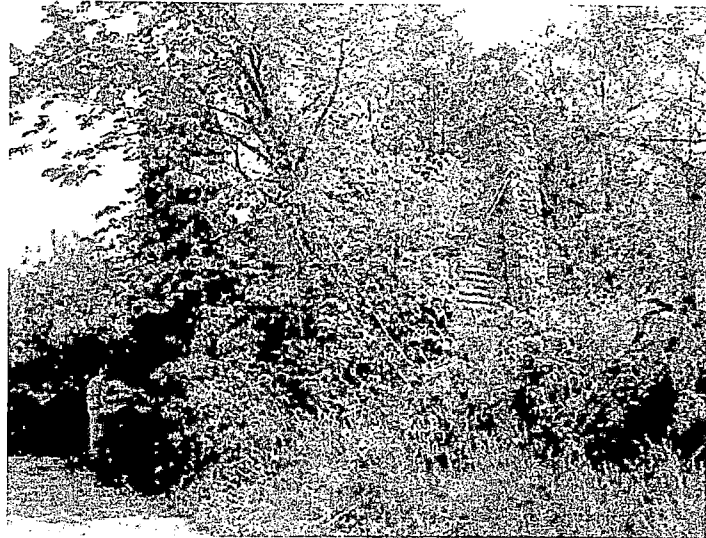
*Site: Vegetation and Grading*

Photographs of the Benson's Wild Animal Farm in its operation period show that the Office and Kitchen area were carefully landscaped. Some of the flowering shrubs and topiary specimens remain in a wild and overgrown condition. Volunteer trees and shrubs have also become established. Features such as the semi-circular stone wall at the SE corner of the Kitchen are part of the original landscaping plan of the Benson's site and should be preserved and repaired.
