# REQUEST FOR PROPOSAL

## ENGINEERING SERVICES FOR BRIDGE DESIGN (109/068) & (110/068) TOWN OF HUDSON, NH

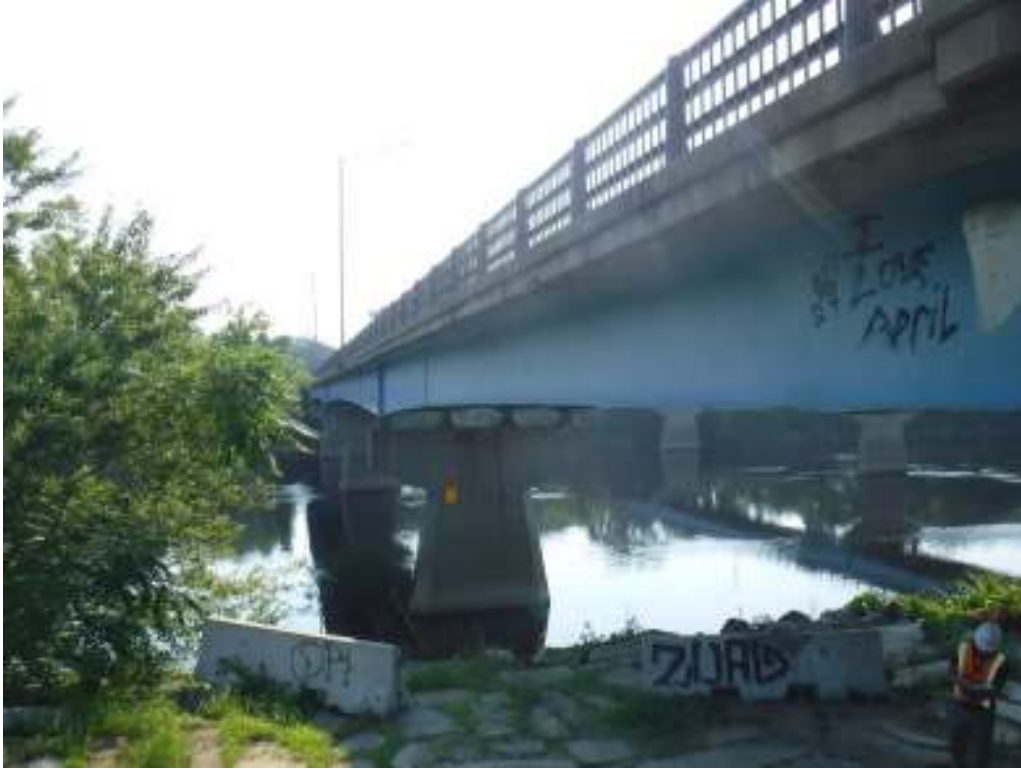
Photo 1 – Elevation view looking south

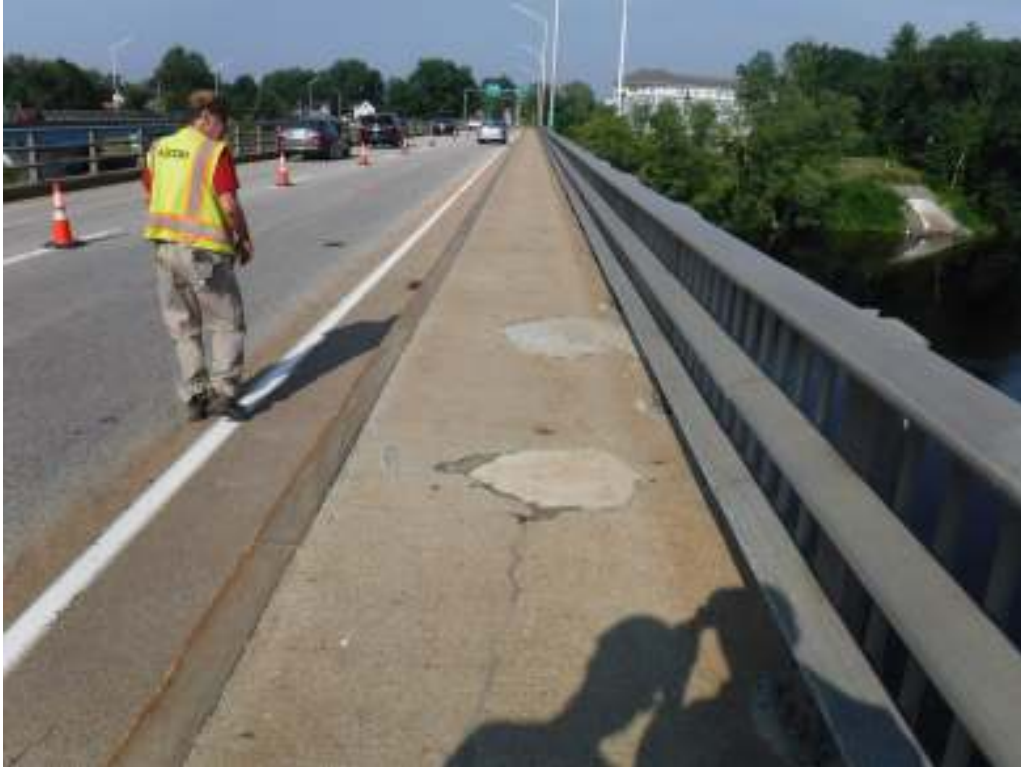
Photo 5 – Typical condition of sidewalk. Note areas of deteriorated concrete and cracking in concrete.

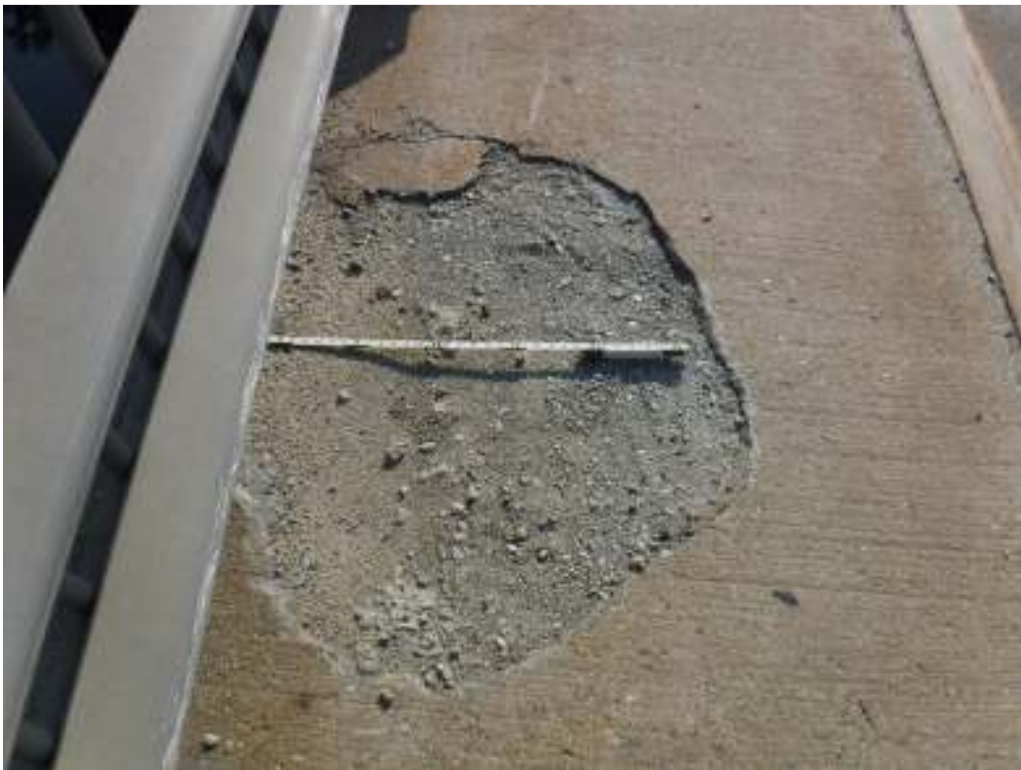
Photo 6 – 3'x4'x1" spall on sidewalk. There are several other similar locations.

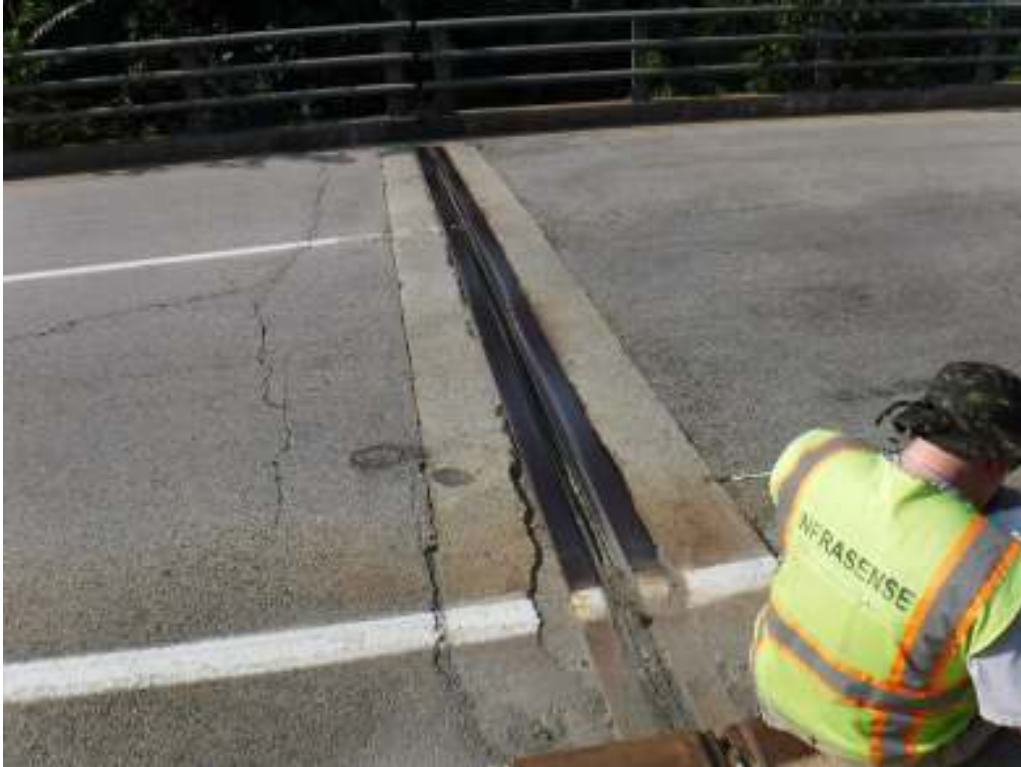
Photo 7 – View of east expansion joint. Note minor cracking in wearing surface on approach and minor spalling of concrete around joint armor.

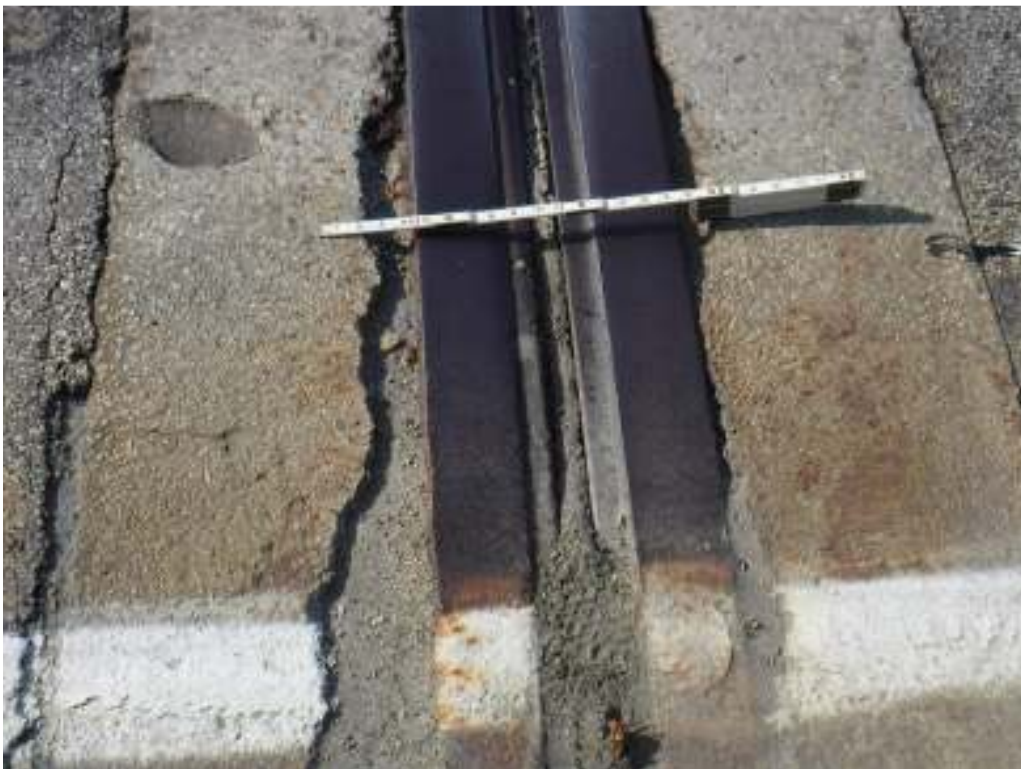
Photo 8 – Close-up view of east expansion joint. Note accumulation of dirt and debris.

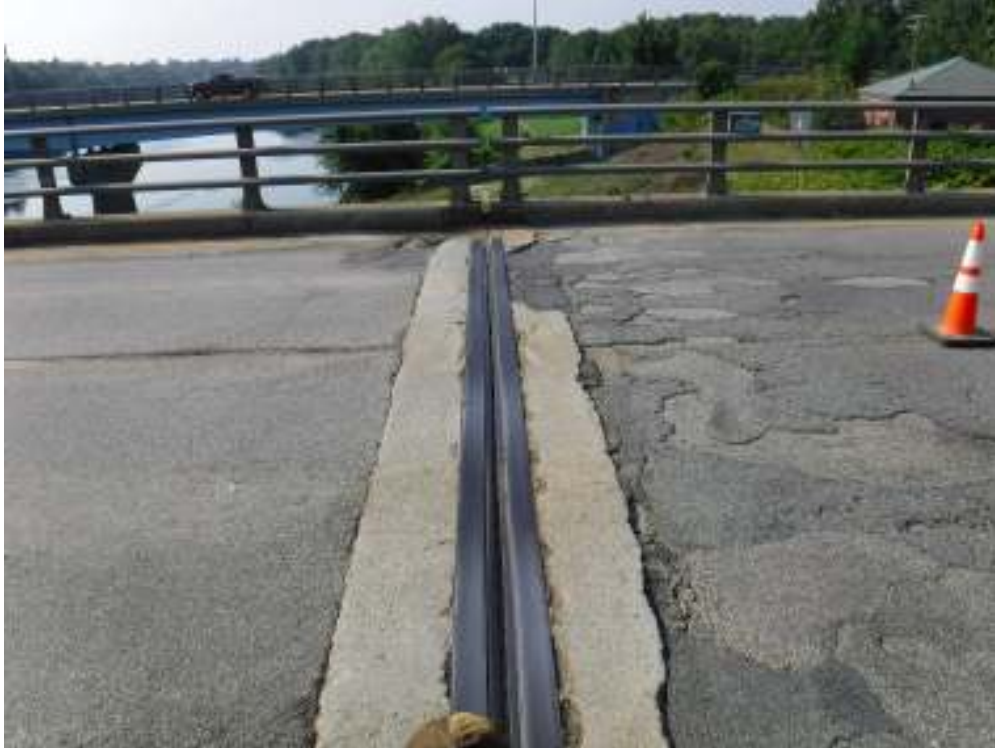
Photo 9 – View of west expansion joint. Note poor condition of wearing surface on approach roadway. Also note the spalled and patched section of concrete on the south end of the joint.

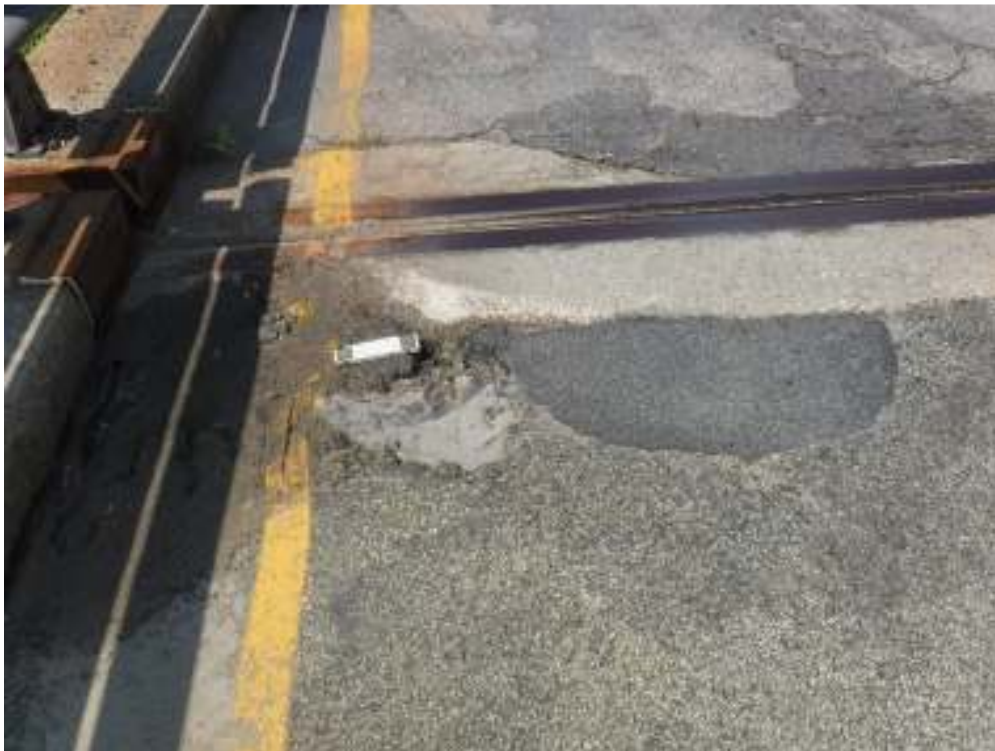
Photo 10 – View of SW corner of bridge at west expansion joint. Wearing surface has popped off, exposing the waterproofing membrane. Also note the accumulation of dirt and debris.

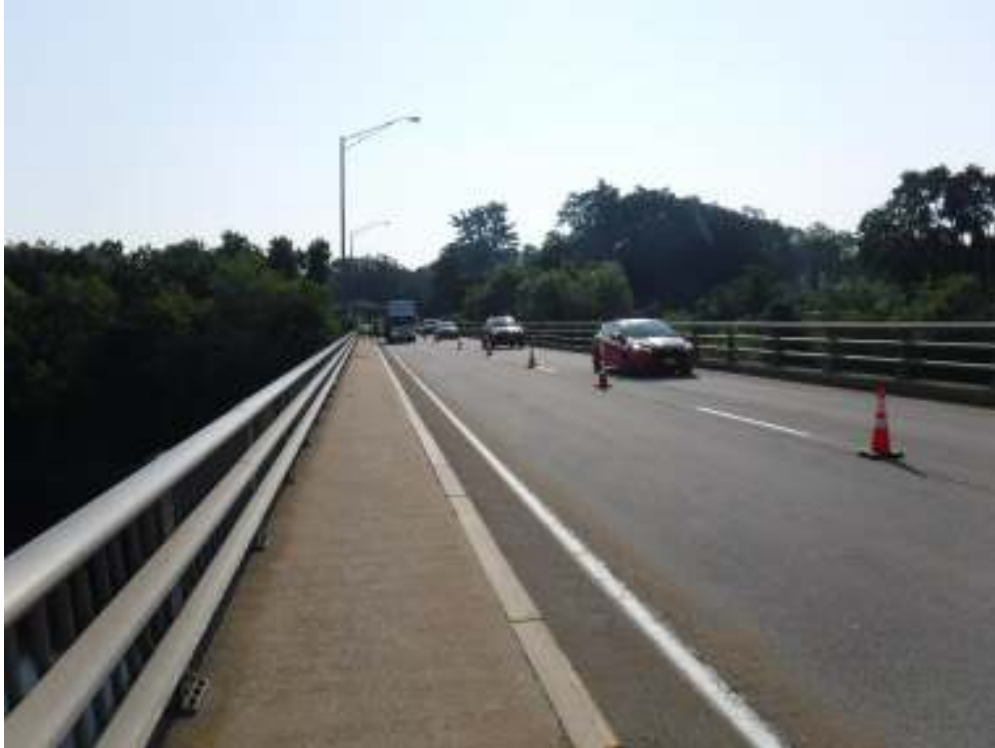
Photo 11 – Typical view of bridge wearing surface. Wearing surface exhibits minor rutting and cracking, with a longitudinal crack full bridge length at center of roadway.

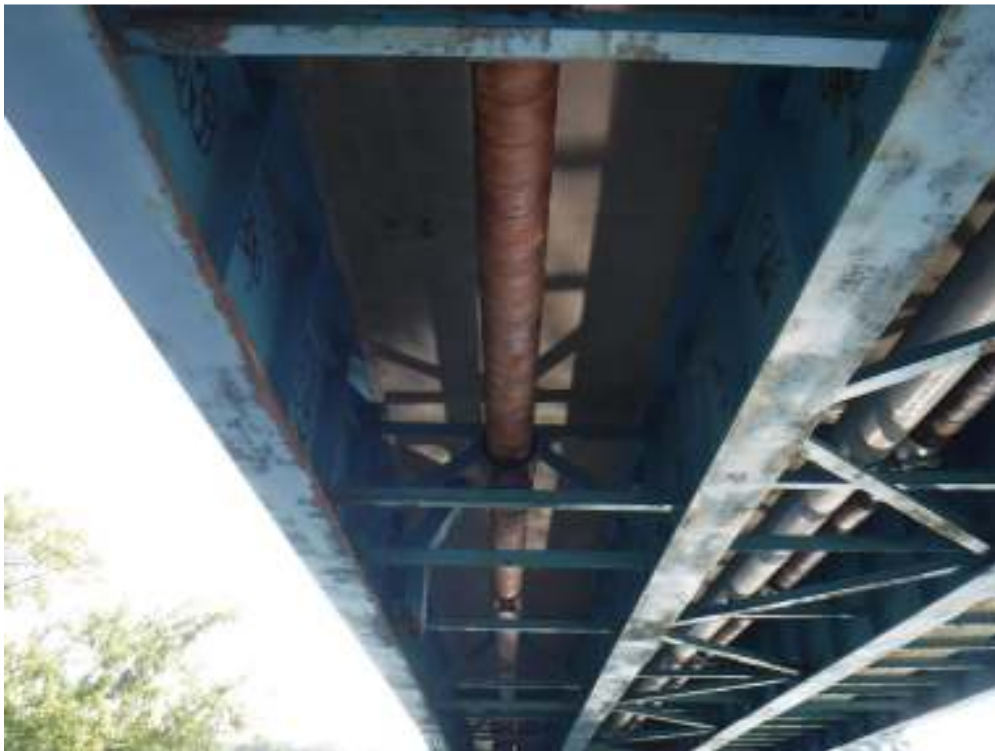
Photo 12 – Typical deck underside in good condition. Note paint freckling of 50% of bottom flange surface along full length of girder.

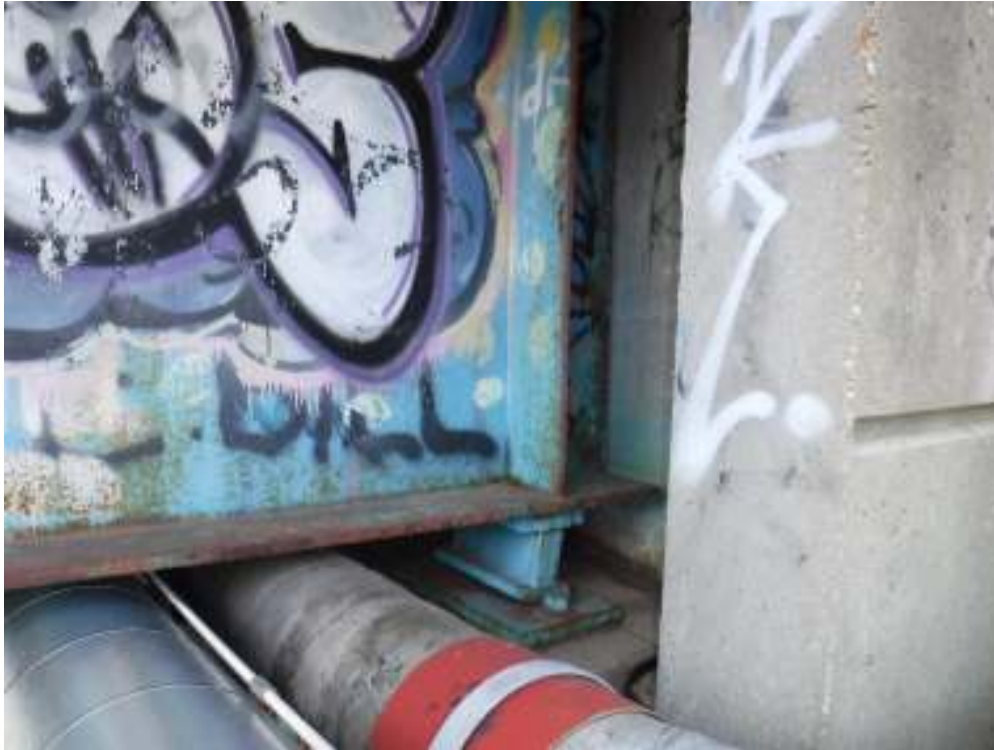
Photo 13 – View of typical girder end condition at west abutment. Note minor surface rust and freckling of paint on bottom flange.

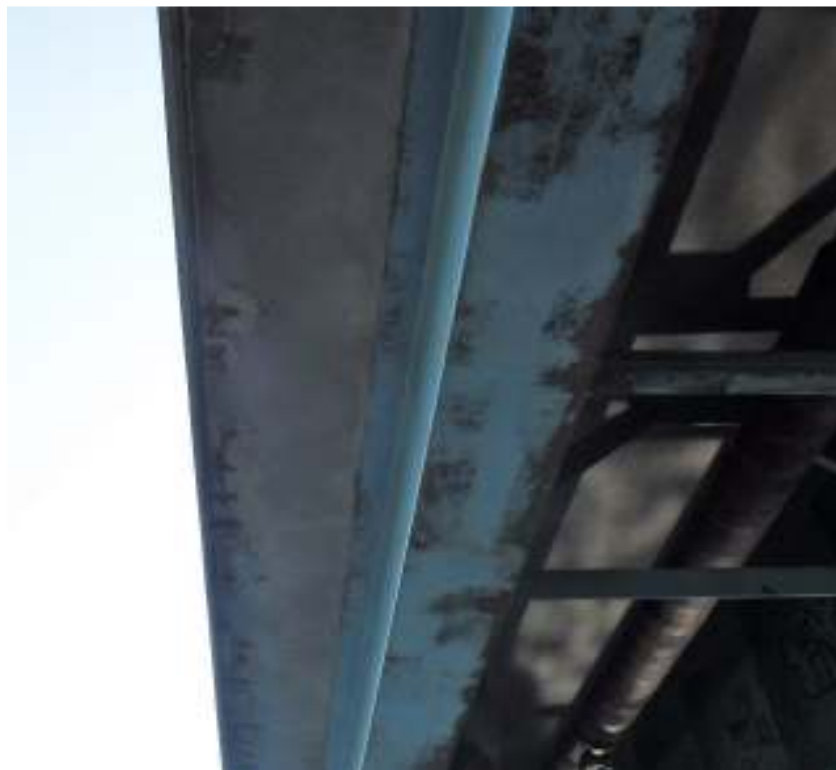
Photo 14 – View showing uniformly spaced popoffs with exposed rebar along length of deck overhang.

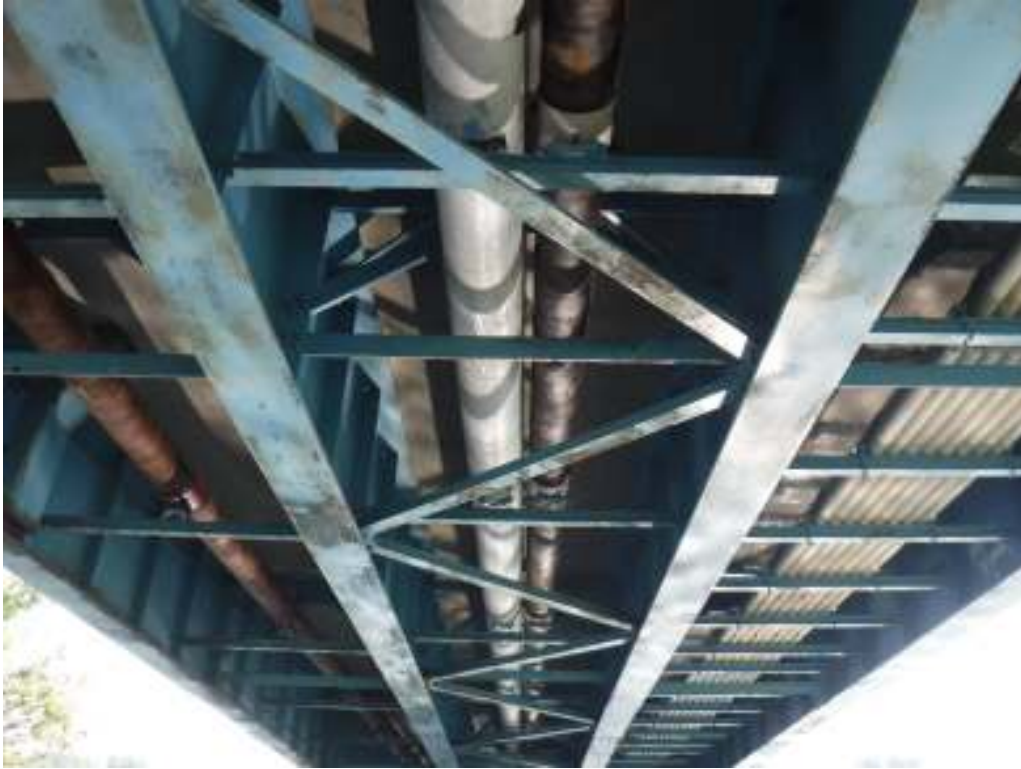
Photo 15 – View showing all bays of superstructure. Note steel girder paint system in satisfactory condition with only minor paint freckling along bottom of girder flanges and lower chord members.

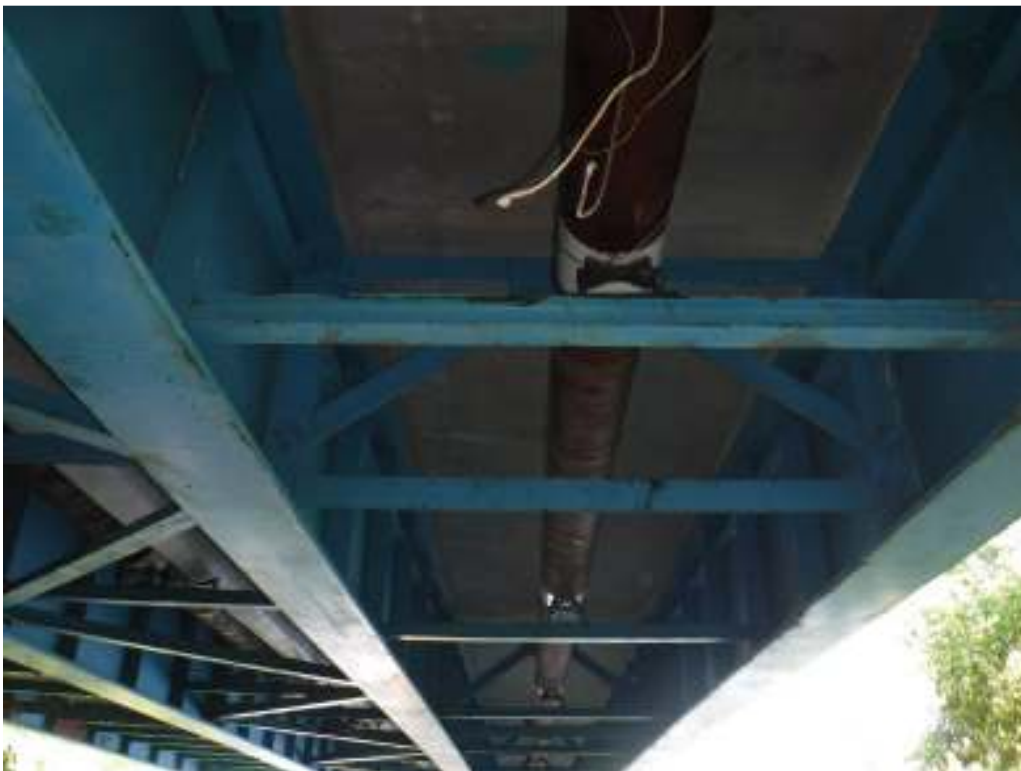
Photo 16 – View showing typical deck underside in good condition in the eastern span.

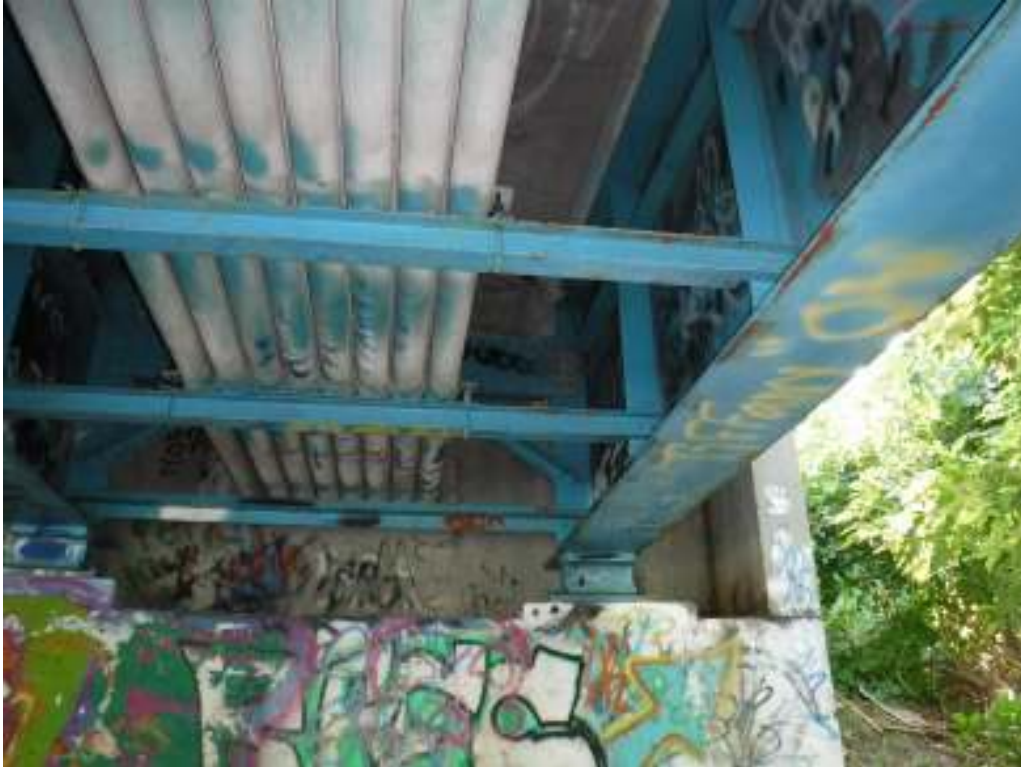
Photo 17 – View showing typical girder end conditions at the east abutment

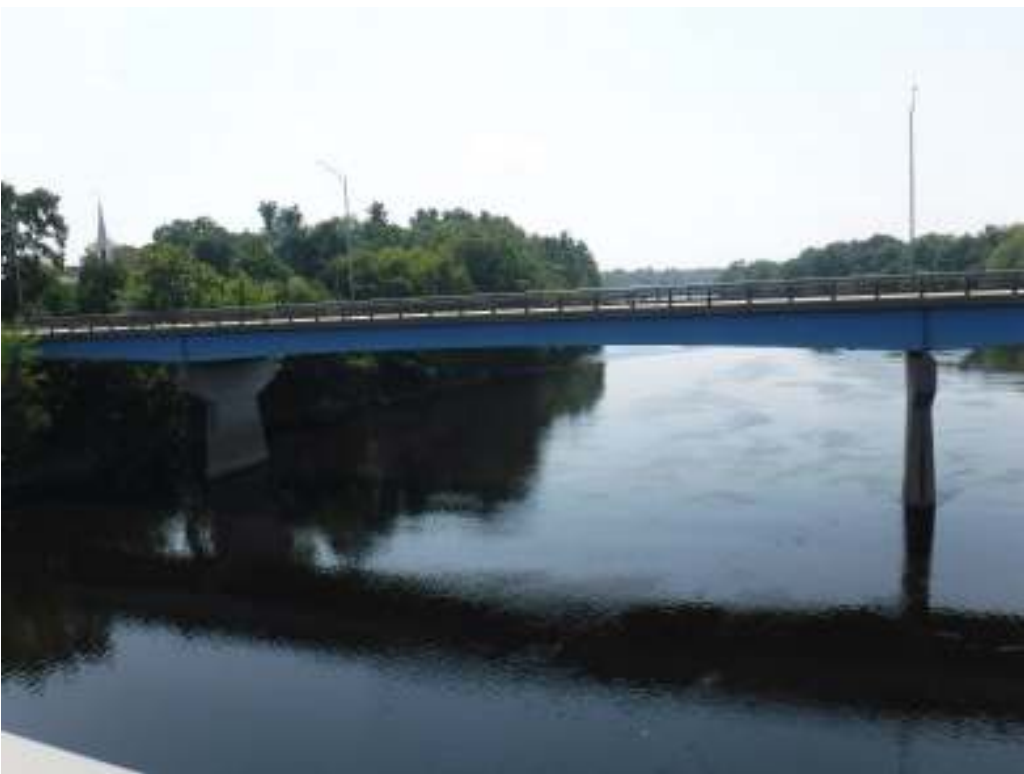
Photo 1 – Typical elevation view looking south

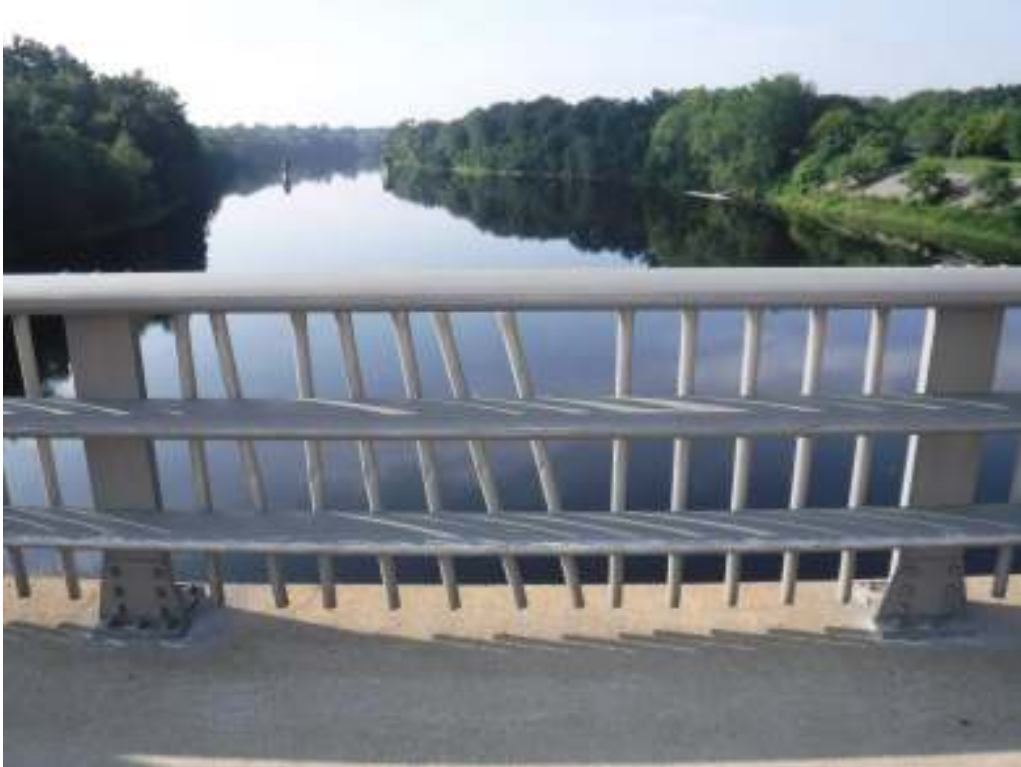
Photo 5 – Typical condition of southern bridge rail on sidewalk. Note scrape damage from plows on rail. There are several locations of bent or missing balusters.

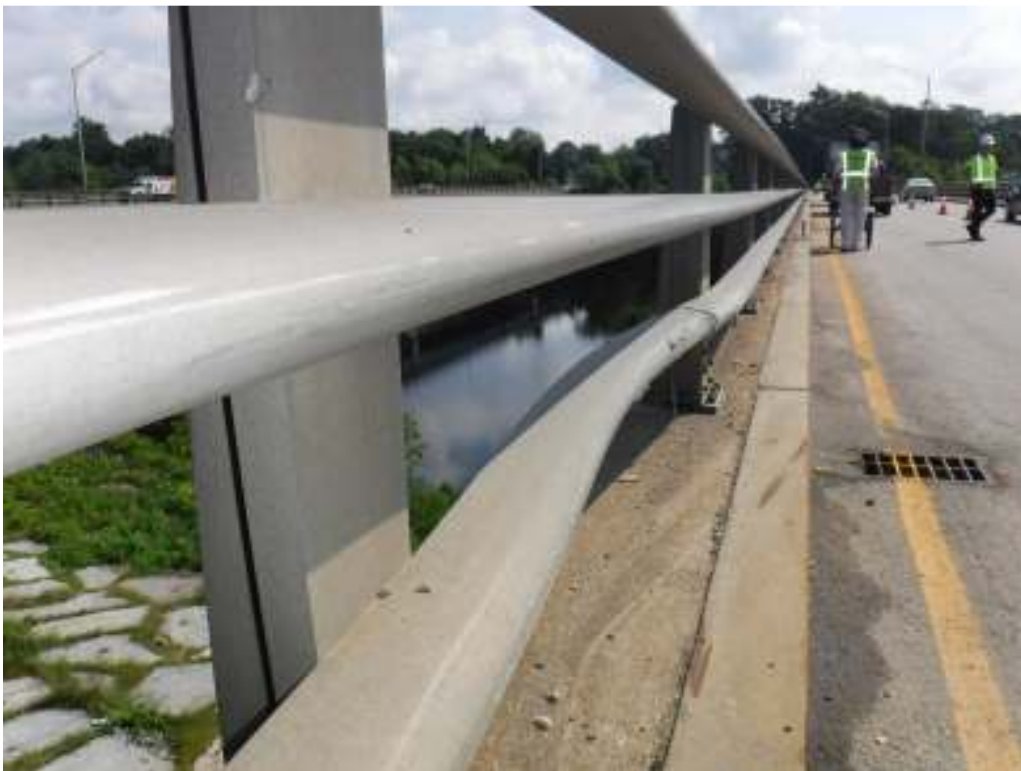
Photo 6 – Damaged bridge rail from vehicular impact on northern curb near northwest corner.

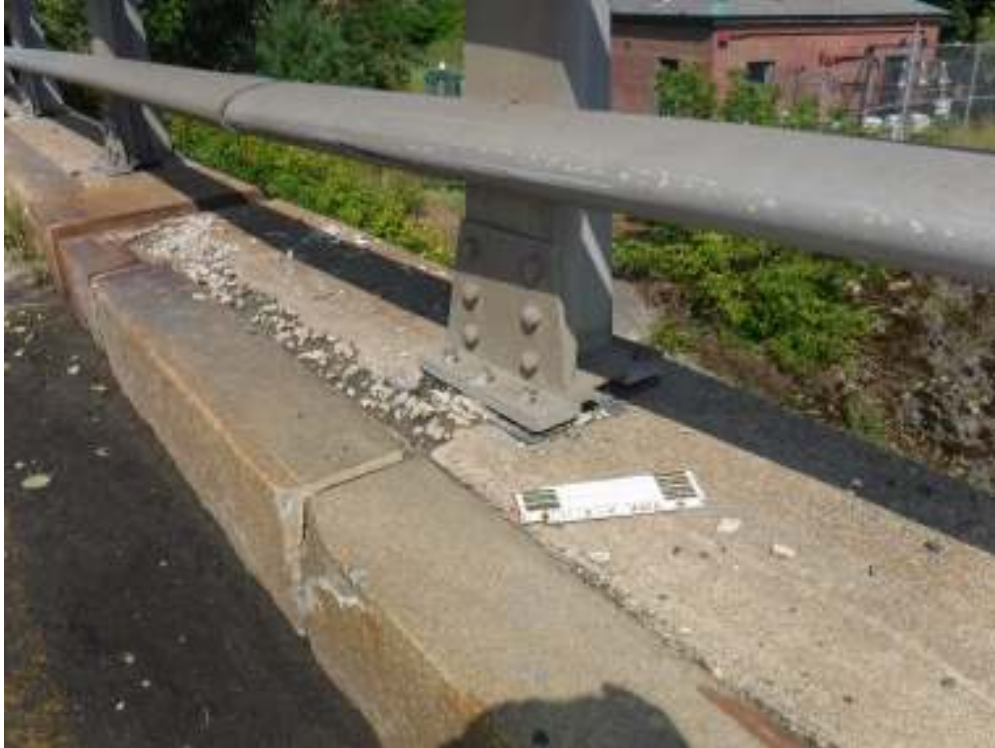
**Photo 7 – Damaged bridge rail from vehicular impact on northern curb near northwest corner. Note that all bolts connecting post to curb have been popped. Also note poor condition of concrete curb.**

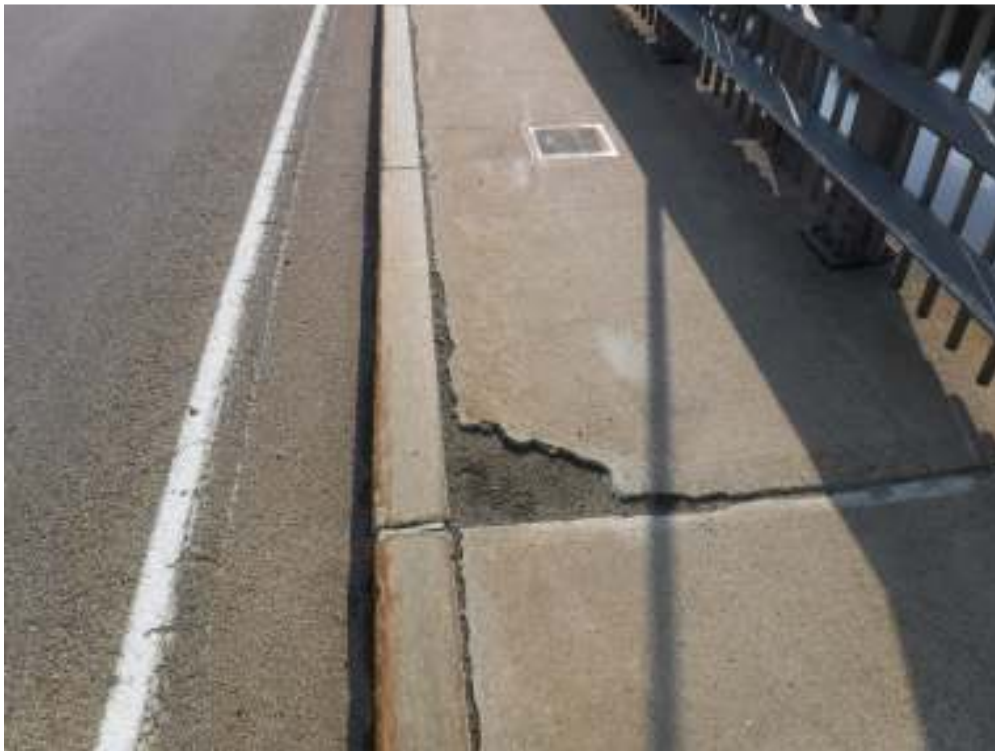
**Photo 8 – Typical sidewalk condition. There are several similar locations of spalling. Note spalling along backside of granite curbing; this is typical each side full length of bridge.**

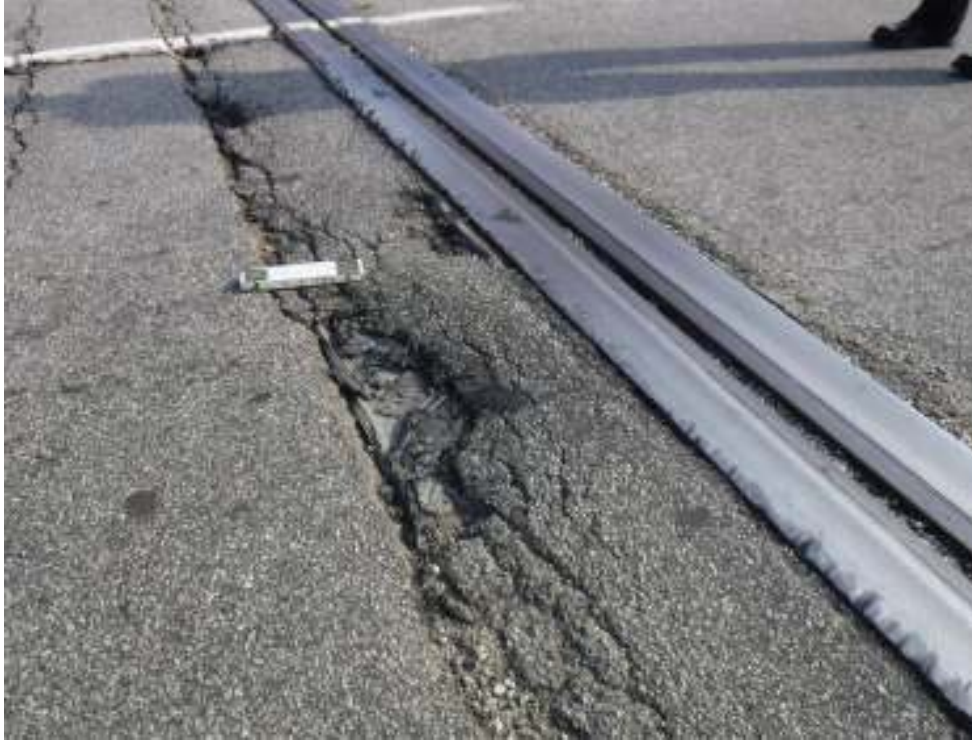
Photo 9 – View of west expansion joint in southern lane. Note full width, full depth transverse crack over backwall width popoffs and exposed concrete backwall.

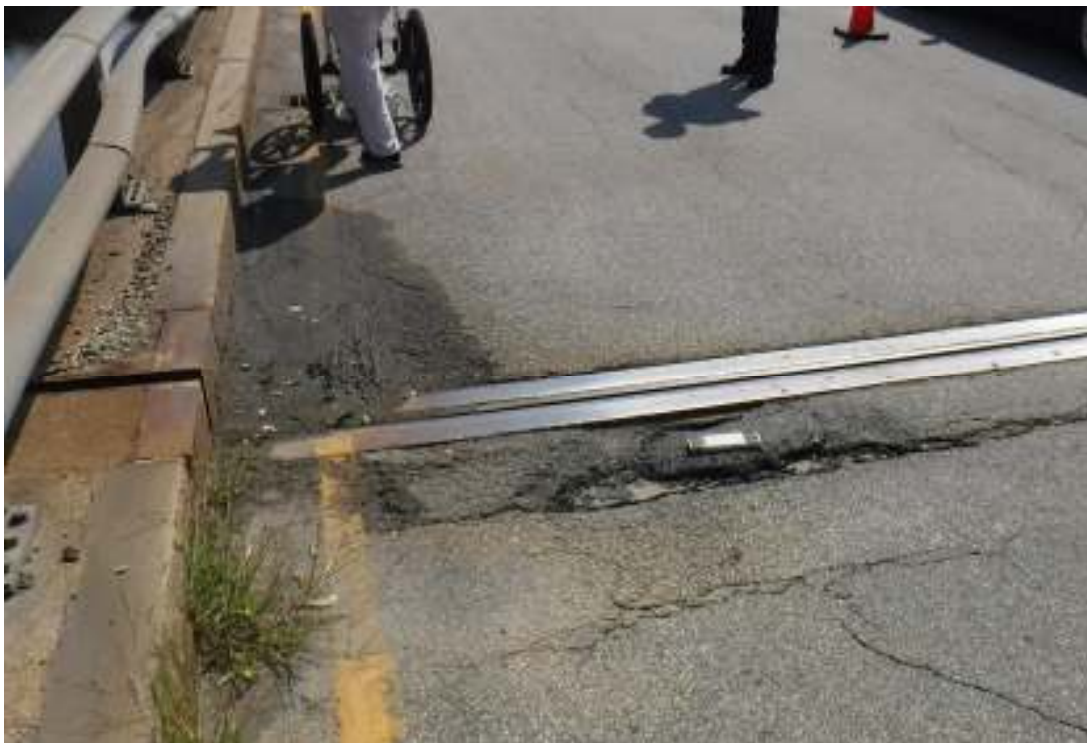
Photo 10 – View of west expansion joint in northern lane. Note full width, full depth transverse crack over backwall with popoffs and exposed concrete backwall. Note accumulation of dirt at NW bridge corner

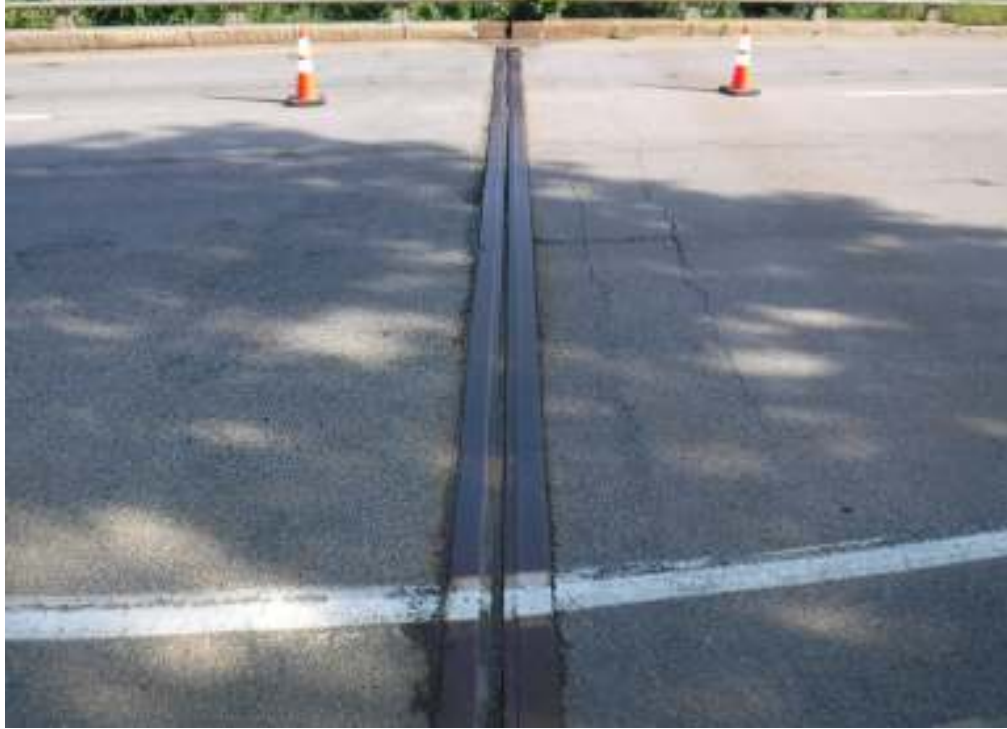
Photo 11 – View of east expansion joint. Note minor transverse cracking in wearing surface over backwall. Note minor wearing surface popoffs along joint armor. Note minor accumulation of dirt and debris in joint.

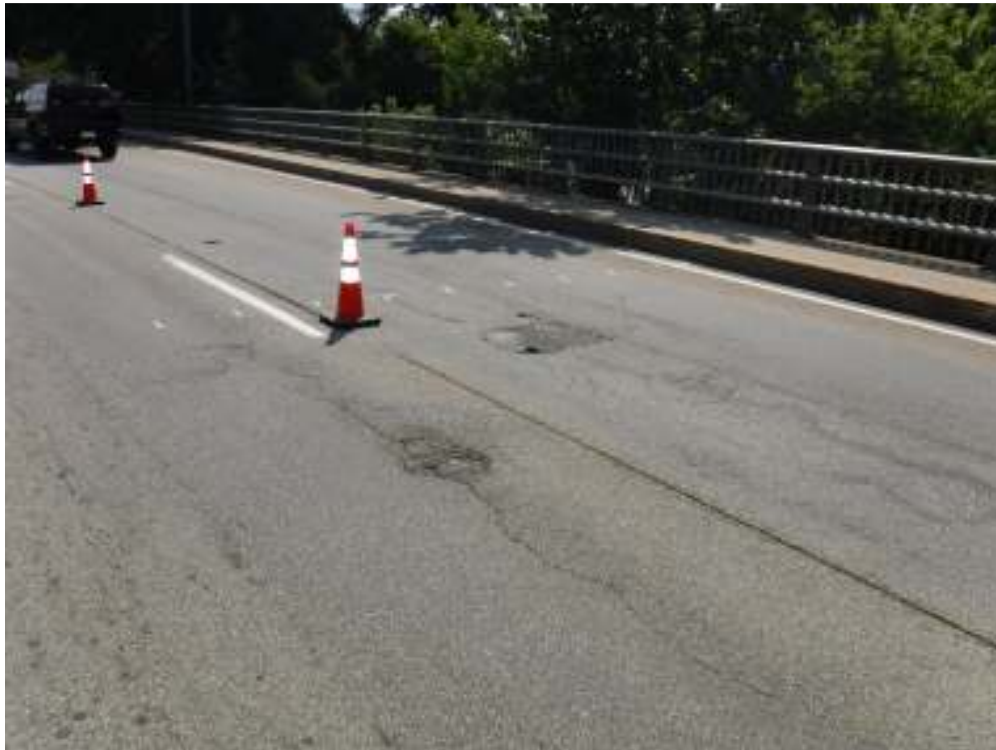
Photo 12 – View showing typical wearing surface condition. Note rutting and longitudinal cracking in travel ways. Also note scattered areas of wearing surface popoffs and patching.

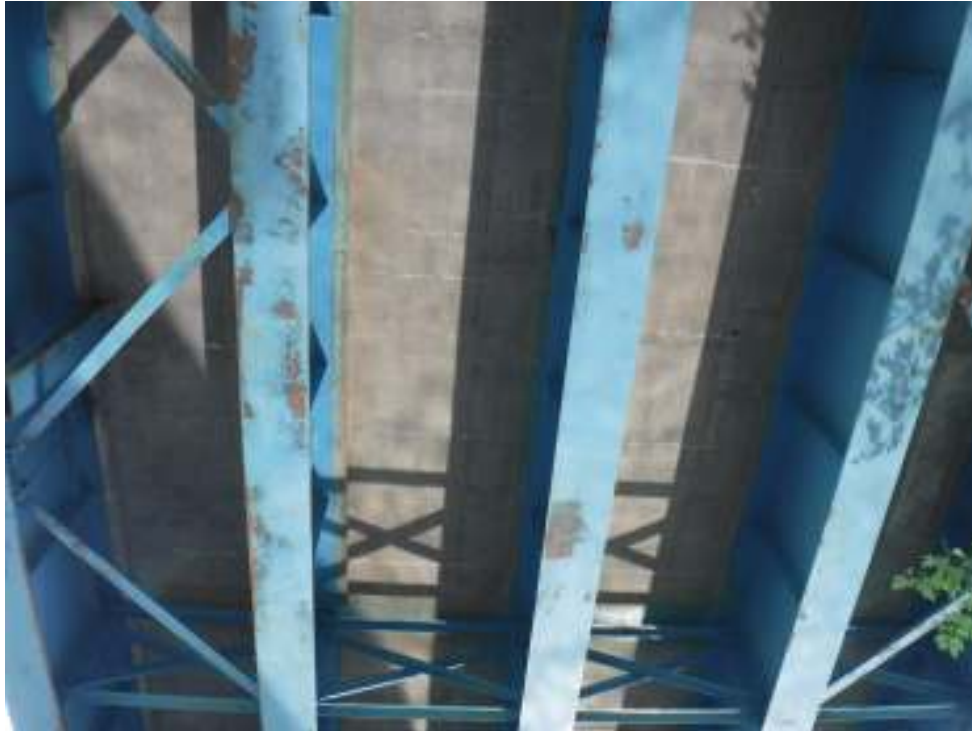
**Photo 13 – Typical deck underside condition in western end span. Note minor hairline transverse cracks with efflorescence staining. Also note scattered locations of steel paint freckling.**

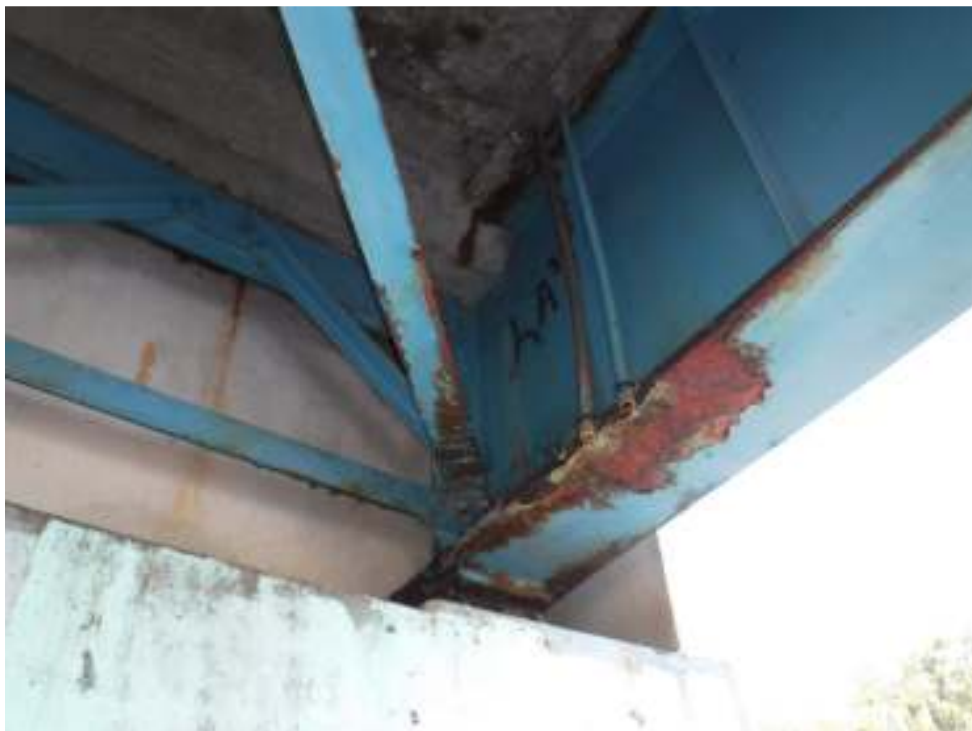
**Photo 14 – View showing condition of northwest exterior girder end bearing. Note paint failure and rusting of girder end due to the leaking expansion joint above. This is not typical, other girder ends are in better condition.**

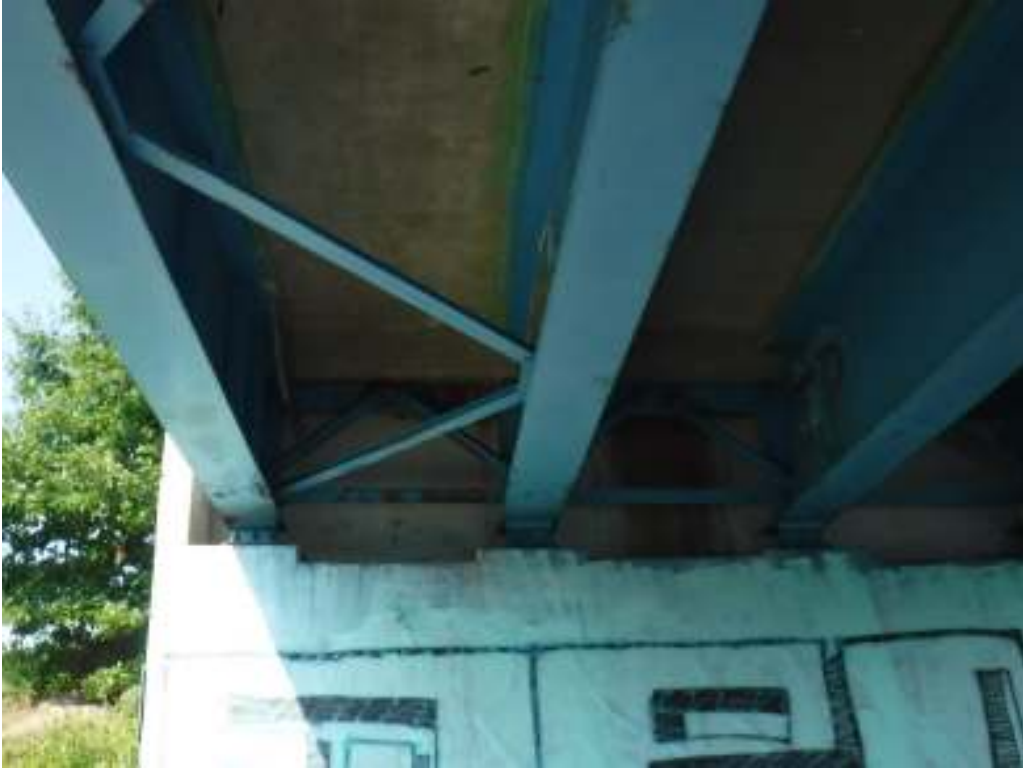
Photo 15 – View showing typical condition girder end condition besides north exterior girder at west abutment. Note only minor scattered paint freckling on girders and end diaphragms.

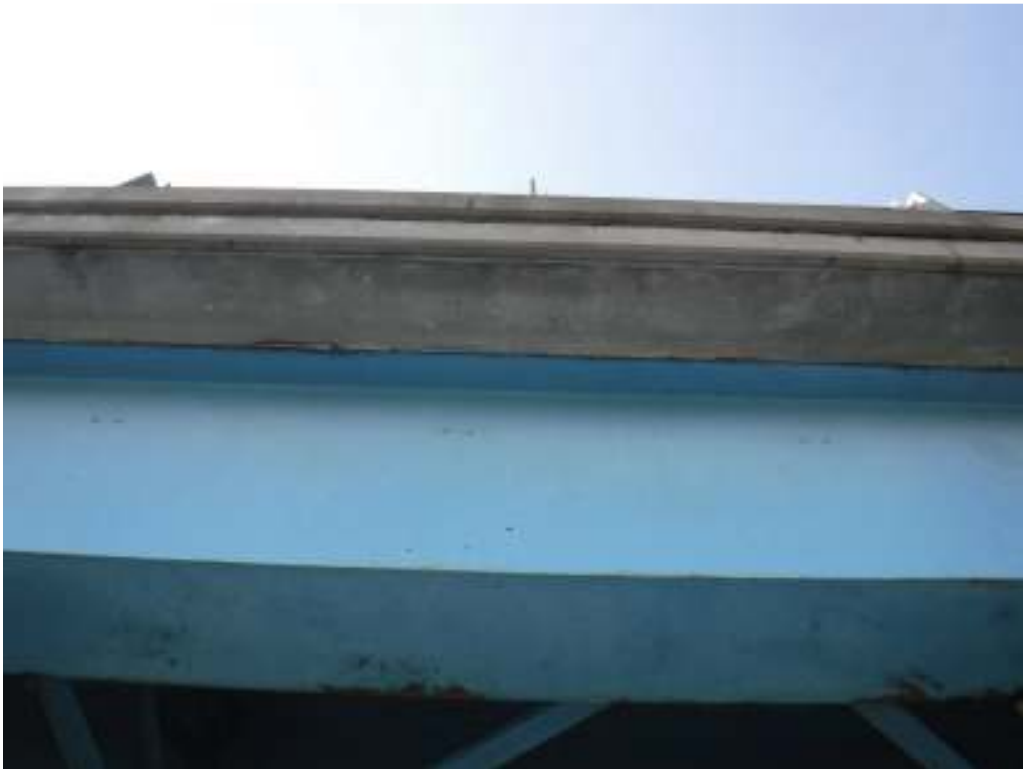
Photo 16 – View of typical deck fascia in good condition. This is typical both sides, full length.

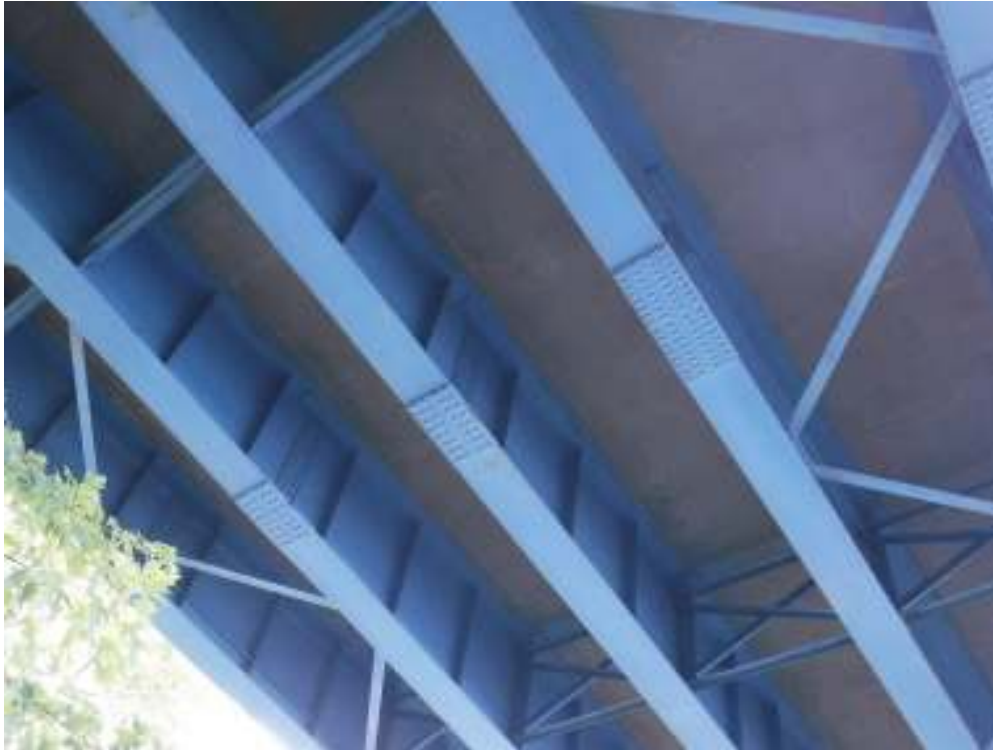
Photo 17 – View showing typical condition of deck underside in east span. Note only minor hairline cracking with efflorescence staining. Also note steel paint system in good condition.

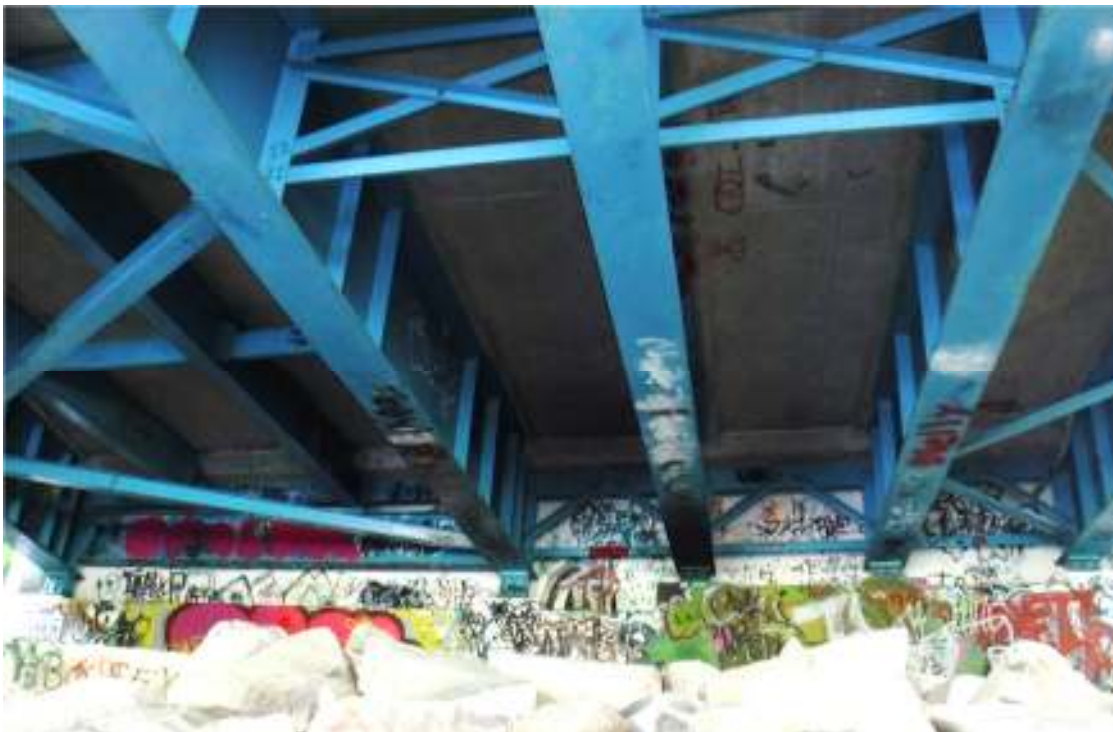
Photo 18 – Elevation view of east abutment. Note girder ends are in good condition with no signs of leakage from expansion joint above. Also note center girder is blackened from a fire under the bridge.
