# REQUEST FOR PROPOSAL

## ENGINEERING SERVICES FOR BRIDGE DESIGN (109/068) & (110/068) TOWN OF HUDSON, NH

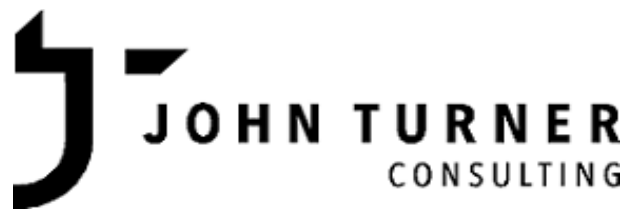
**Summary of Chloride Ion Content  
ASTM C1218**

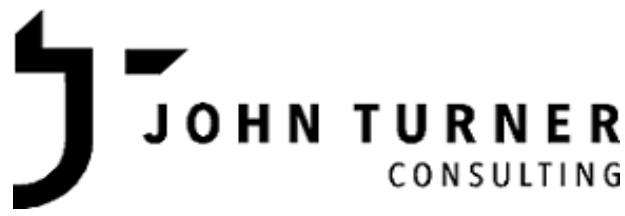
**Summary of Chloride Ion Content  
ASTM C1218**

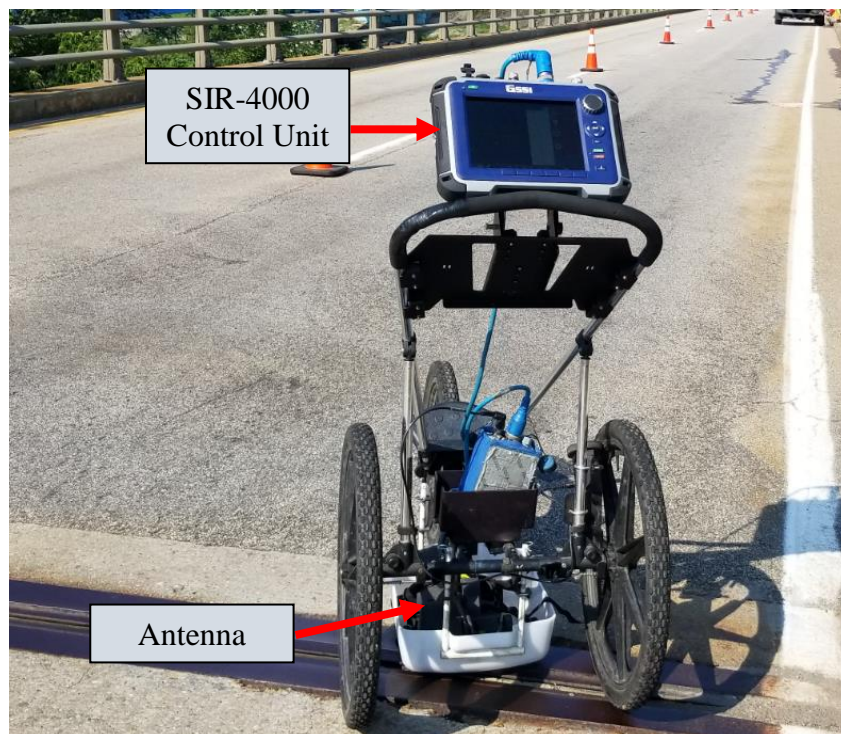
Figure 1 – GPR Survey Setup – Control Unit and 900-MHz antenna

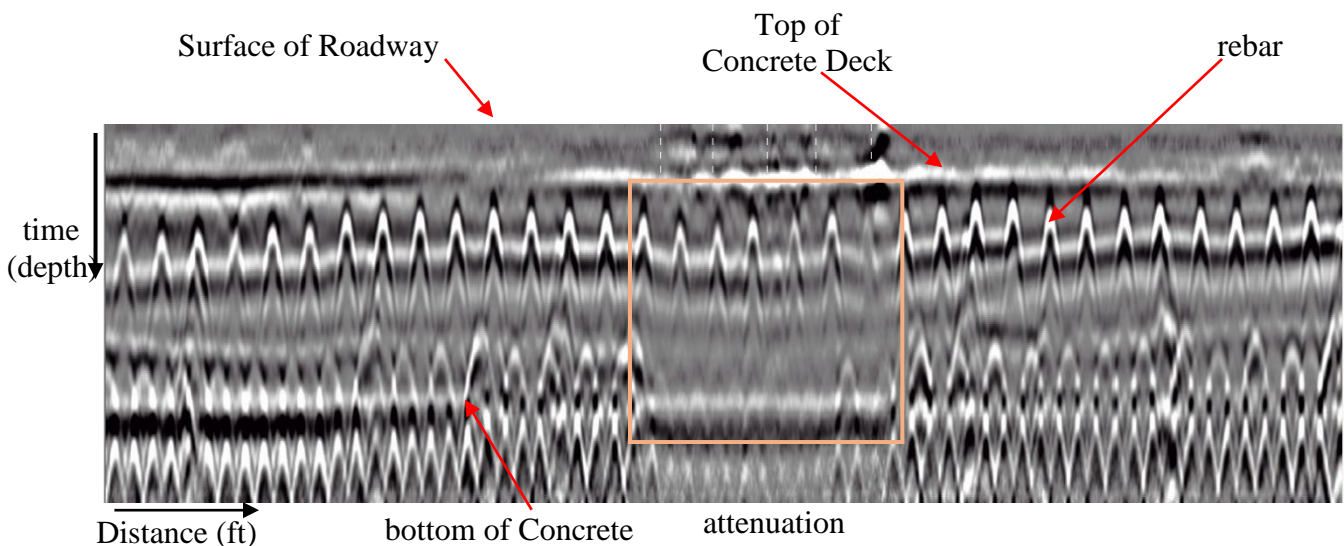
Figure 2 – GPR Data Sample  
(Route 111 eastbound, Left Lane)

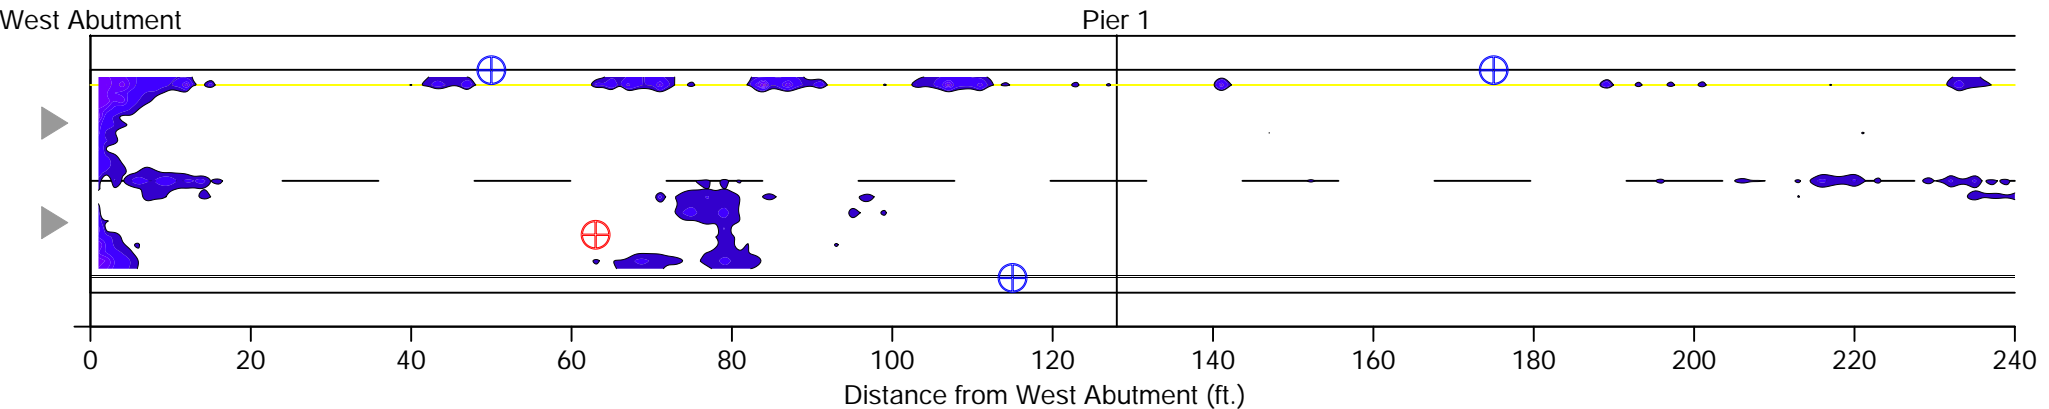
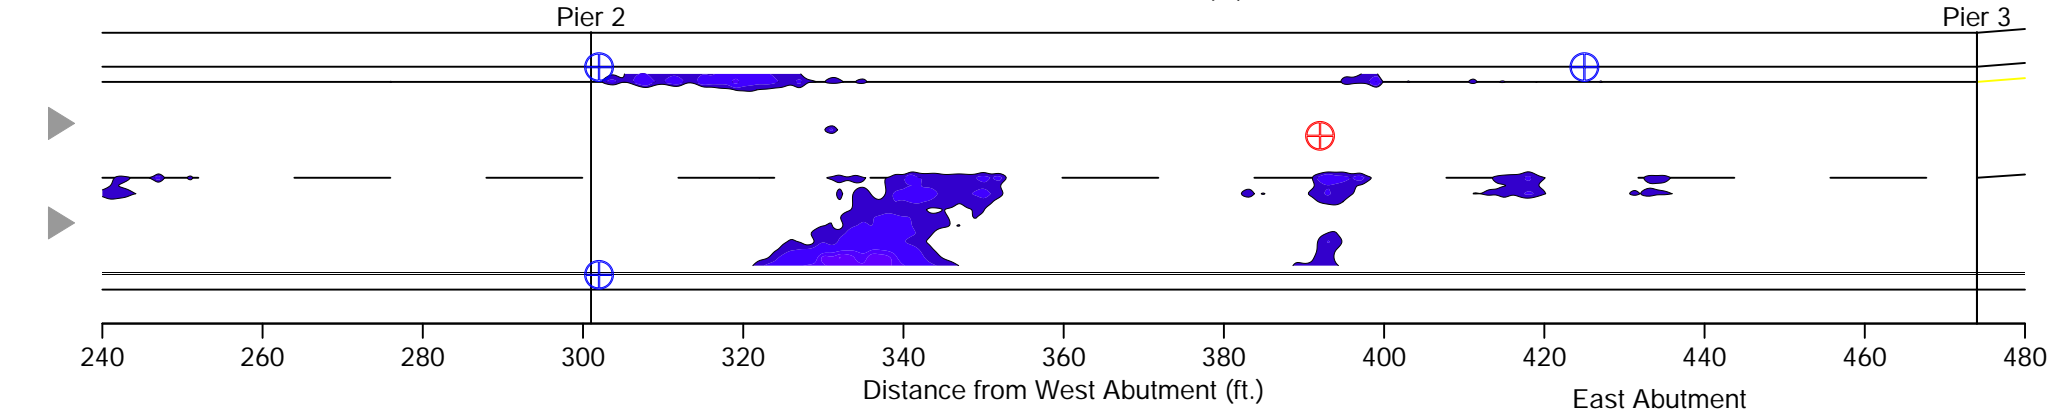
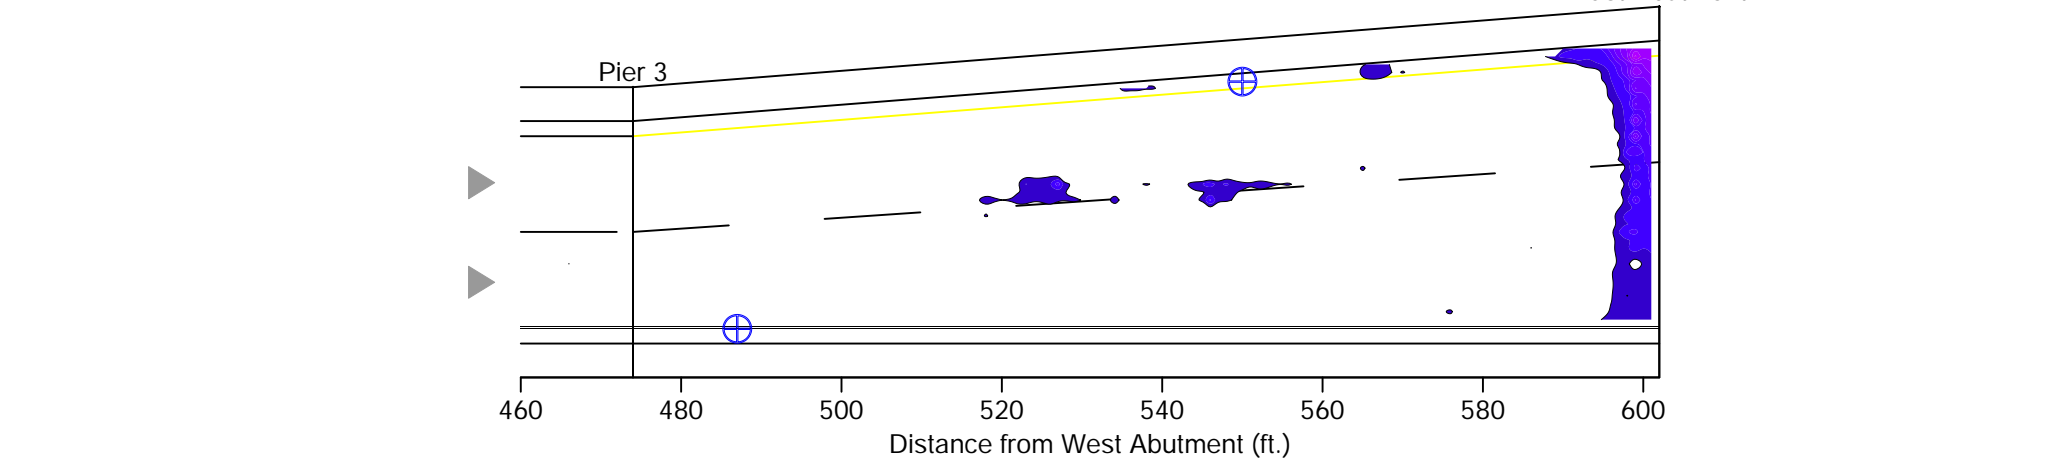
Concrete Condition Legend	Orientation	Quantity Summary		General Information	
<p>Deterioration</p> <p>Increasing severity --&gt;</p> <p> 2" Diameter Core</p> <p> 4" Diameter Core</p>	<p></p> <p> Direction of traffic</p>	Condition	Conc. Deterioration (%)	4.6	Ferry Street Bridge Rt. 111 EB over Merrimack River
			Conc. Deterioration (s.f)	706.5	Analyzed by: PG Reviewed by: KS Completed: 9/03/18
					<b>Sheet 1 of 1</b>

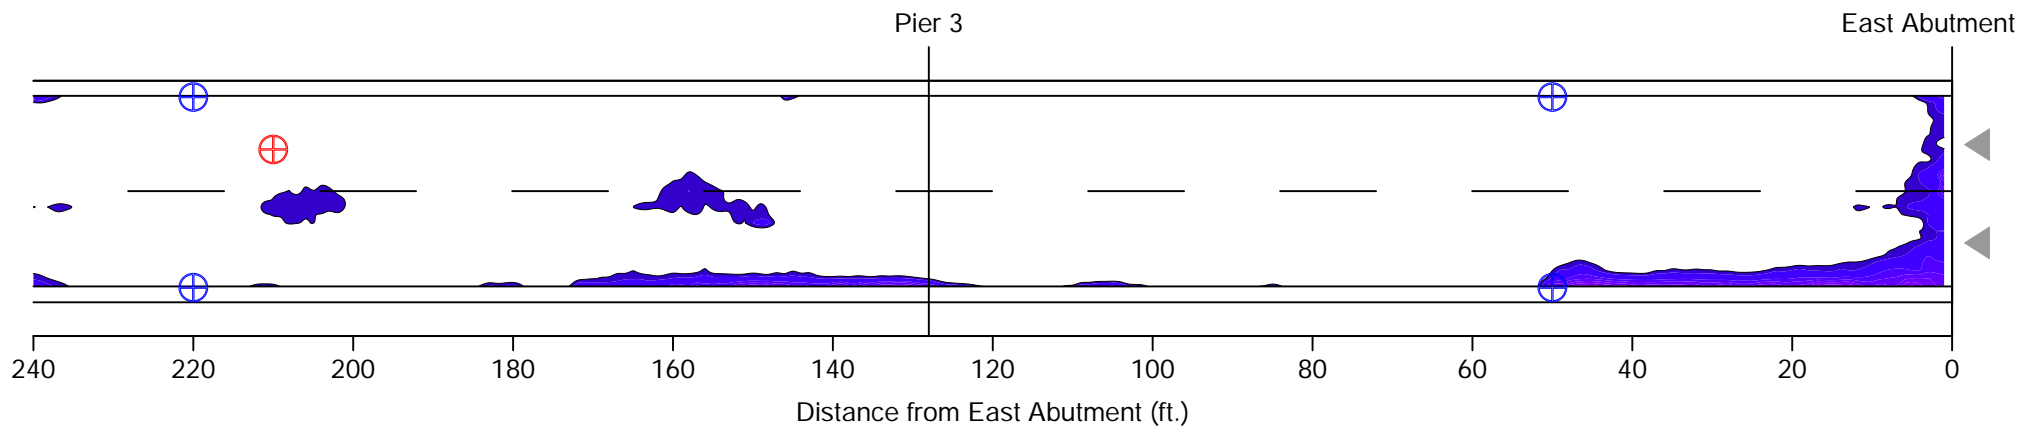
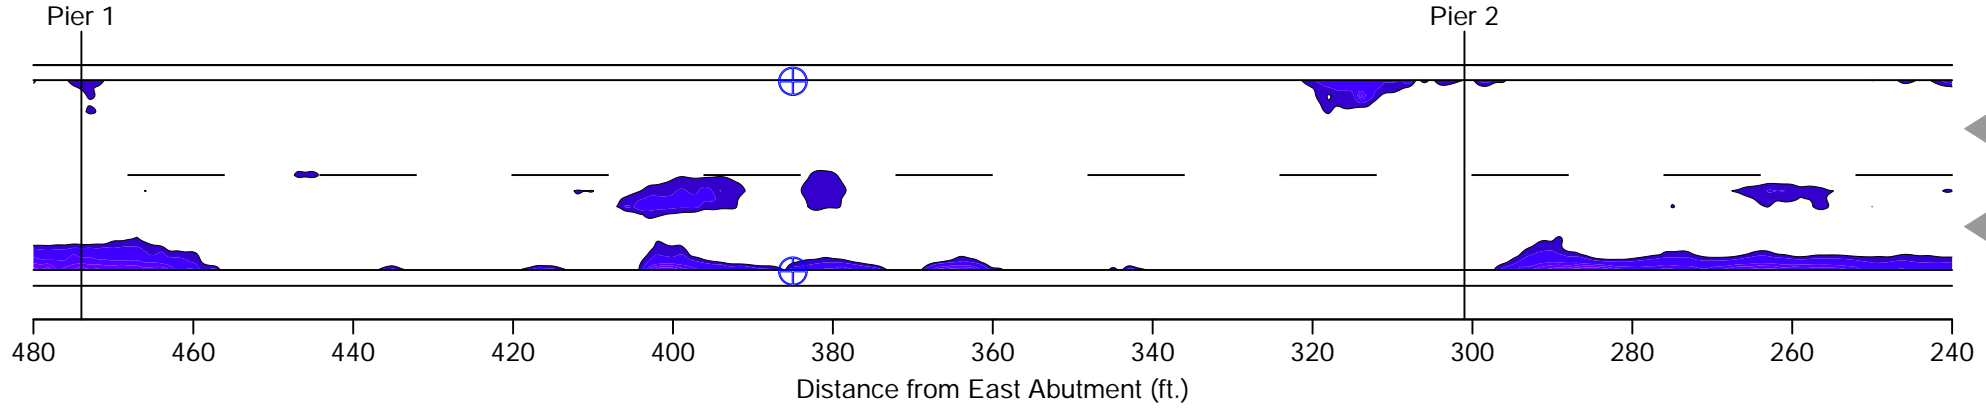
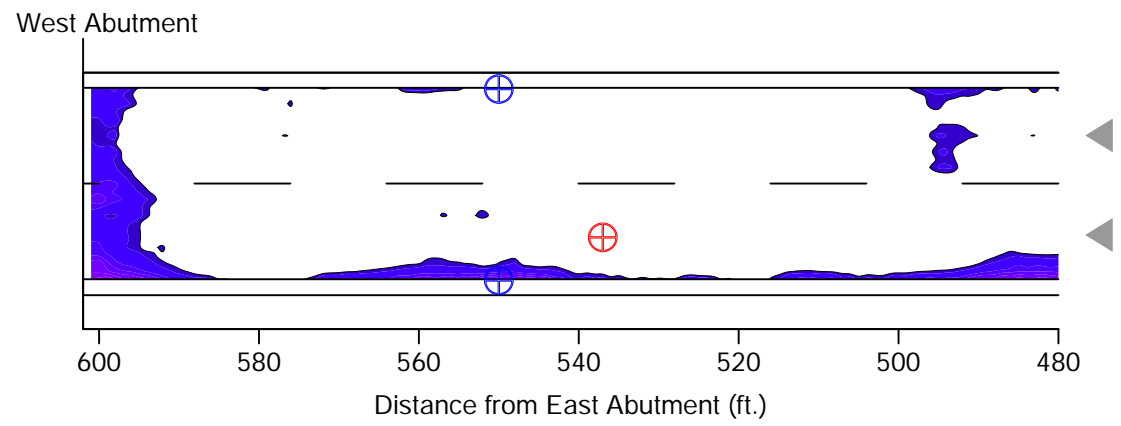
Concrete Condition Legend	Orientation	Quantity Summary		General Information	
Deterioration Increasing severity -->

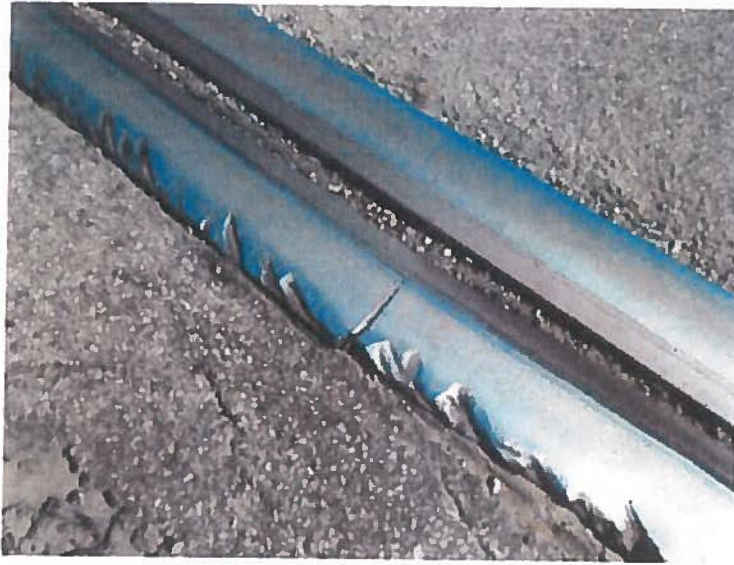
**JOINT ARMOR CRACKED  
NEAR CENTER, WEST.**

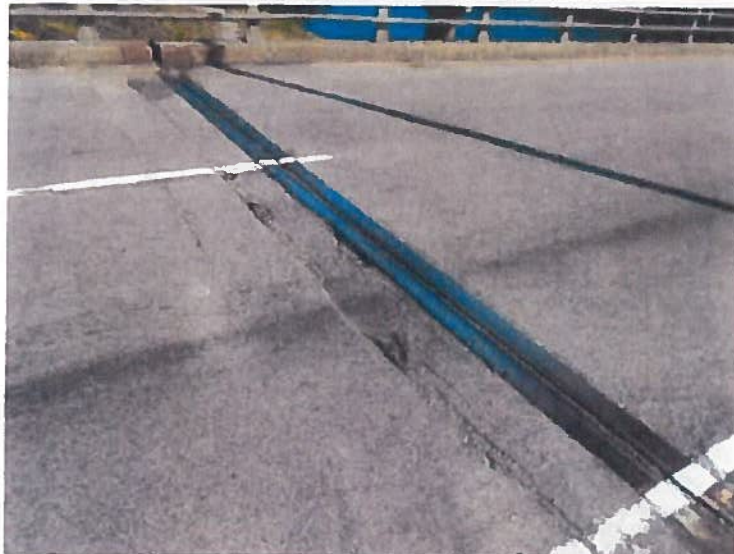
ASPHALT CRACKED AND  
POTHOLED ALONG JOINT,  
WEST.

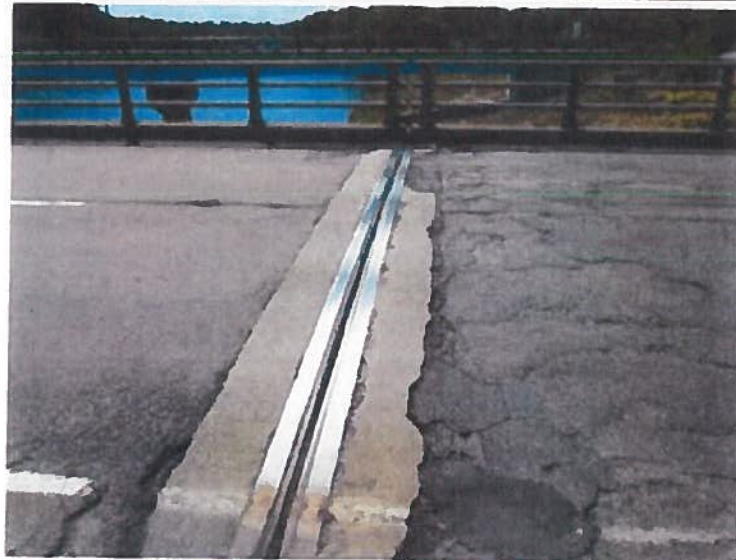
TOP OF SOUTHWEST  
BACKWALL SPALLED  
ADJACENT TO JOINT.

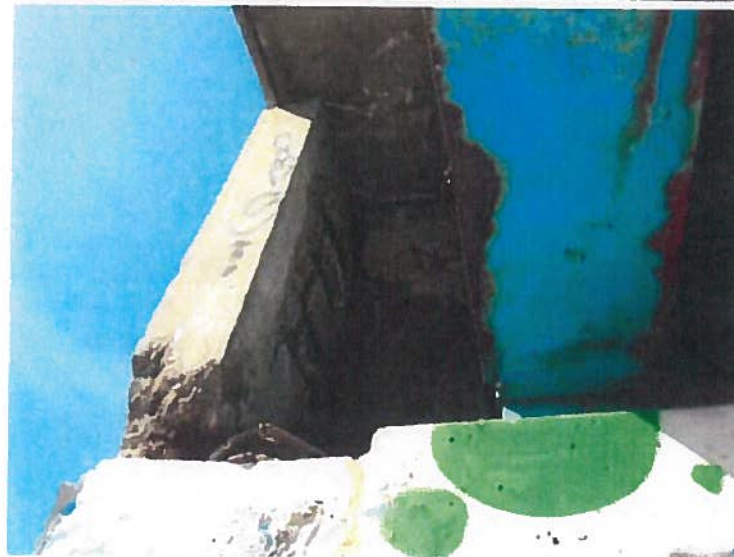
INTERIOR OF SOUTHWEST  
CHEEK WALL SPALLED  
WITH REBAR EXPOSED.
