Historic Structures Report

Benson's Property

Town of Hudson, New Hampshire

B&M Railroad Depot

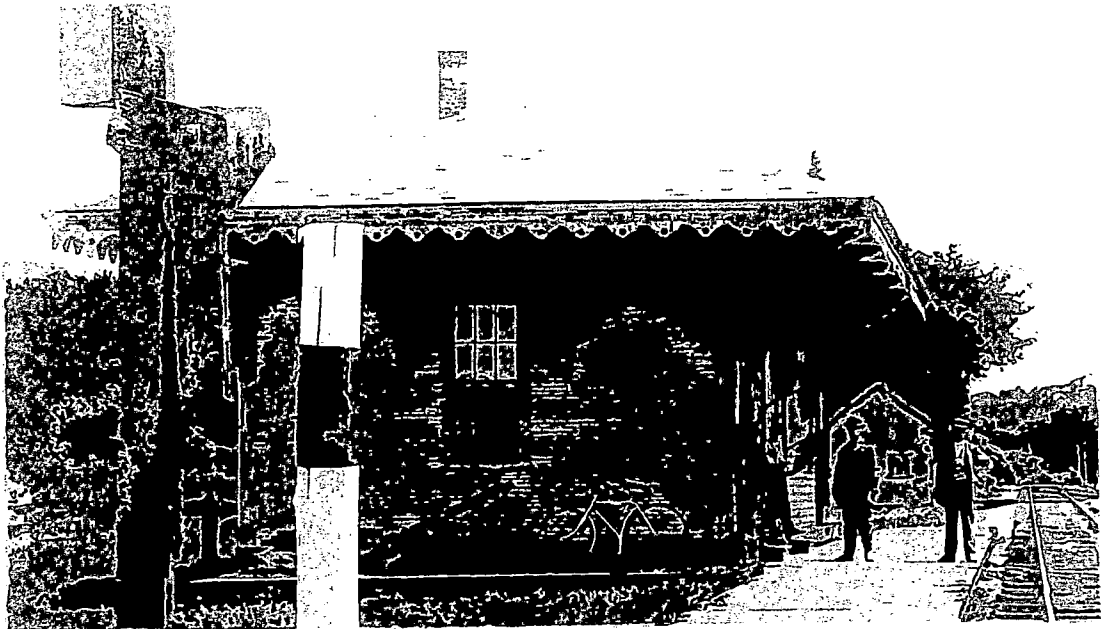
Exterior: Cornice and Gutter

The Depot originally featured a boxed gutter and 4 leaders at the corners of the building. The leaders apparently discharged through leader extensions below the wood deck, which carried the rainwater away from the building. The boxed gutter was faced with an ogee profile wood cornice, and decorative eave boards. The eave boards show a repetitive pattern of stepped round and 1/2 round cuts. The soffit below the wide 6'-6" overhang was finished with beaded boards.

The condition of the boxed gutters could not be determined with the existing tarp and asphalt roof. It is possible that they were covered over with asphalt shingles. The decorative eave boards have been removed, and the condition of the cornice moulding could not be determined. The leaders have also been removed, and the openings from the gutters patched in the board soffit. Examination from the attic interior showed that the existing flat eave boards have been damaged in some locations by rainwater intrusion and animals. It is anticipated that the overall condition of the gutters is poor. Restoration of the gutter and cornice features should take place in conjunction with the replacement of the roof after the building is moved to a permanent location.

Treatment Description: Repair wood soffit

Repair or replace in-kind missing or damaged 1"x 6" T&G wood soffit boards

Treatment Description: Fabricate and install decorative eave board
The size and layout of the decorative eave board can be determined from proportional analysis of the historic photographs to exactly reproduce the size and profile of the replacement. A custom millwork shop can fabricate the material from 7/8" Northeastern White Pine stock.

Treatment Description: Repair/replace wood boxed gutter and cornice
Repair or replace in-kind the wood base of the boxed gutter with kiln-dried, pressure treated lumber, and slope toward outlets. Carefully note and document evidence of cornice and gutter dimensions or profile using paint shadows, nailing patterns, or other architectural fabric information. Repair any deteriorated rafter ends prior to boxed gutter installation. Repair or replace cornice moldings as needed.

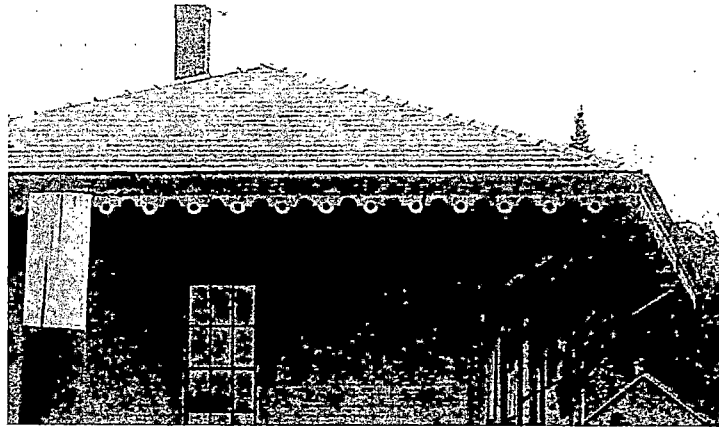
Roof

The hip roof is constructed at 5:12 slope. The original slate roof shown in the historic photographs was removed and the existing asphalt shingles were installed, possibly during the remodeling of the Depot into a residence. The existing asphalt shingle roof is failing and allowing water into the structure, which is presently covered with a tarp, secured at the eaves.
