Historic Structures Report

Benson's Property
Town of Hudson, New Hampshire
May 22, 2003 – 100% Submittal

Haselton Barn Feature Inventory and Condition Assessment

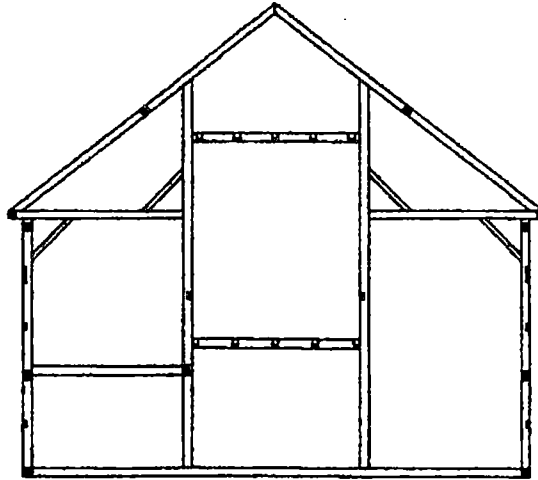
Main Barn: Bent Two

Bent two is in good shape overall. Joinery systems are intact at all critical locations. Bent two is well supported by the building's rubble stone foundation on the north wall. The south wall is also supported by the foundation with some damage but it is bolstered by the added silo ell.

Treatment Description: Bent two: control for repairs

Bent two is perhaps the most intact of all the major barn bents. It does not reveal any failure in tension nor does it sag across its length. Treatment here should be kept to a minimum and focus on this bent as a control for height and width of remaining bents is appropriate.

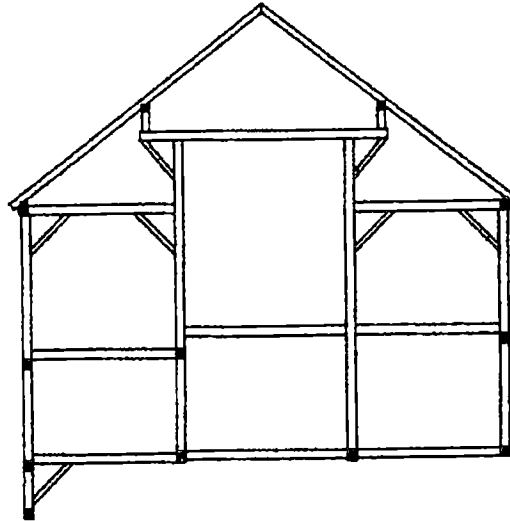
Main Barn: Added Bent Eight

Bent eight is built very similar to bent seven with mill rule layout and dimensional timbers. Every element is circular sawn from softwood species. A significant distinguishing feature of this bent is seen at the roof level. The 6"x 6" principle purlins that cross the short posts in both bents seven and eight extend beyond the plane of bent eight and diagonal braces help support the ends of these extensions. At the very end of the plate is a tie beam upon which the hip rafters, which make up the rear portion of the roof, sit. The two principle purlins are scarfed over the tops of the short posts in bent eight. These scarf joints are heavily loaded by the roof weight associated with the hip roof.

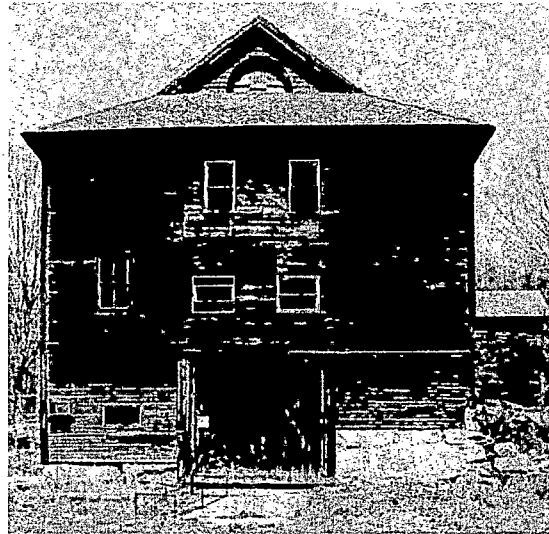
West Gable End

The west gable end of the barn begins at grade at the back of the barn. It shows the cellar level, first and second floor levels and then a hip roof is visible back two thirds of the way into bay eight where the gable peak becomes visible with an arched transom light in the peak of the barn. There are two windows at the second floor, four windows at the first floor level and one window and a large sliding door at the cellar level. The sliding door slides towards the south eave wall when opened and behind it is an overhead garage door allowing access to the cellar. The sliding door and hardware appear to be original to the added bays of the barn. All other window openings have smashed window sash and damaged frames. The arched window in the west roof peak is missing as well. Only the frame of this window remains. Siding is clapboard like the other three sides, with many clapboards missing and horizontal sheathing deteriorated. The foundation stones come well above grade to protect the sills of the wall.

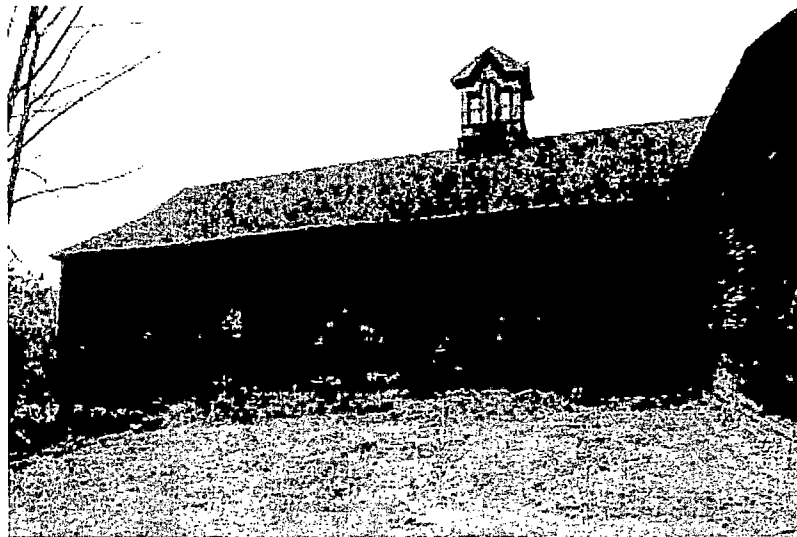
Main Barn: South Eave Wall Exterior

The south eave wall shows at the grade entrance into the first floor of the barn. Openings denote the exit and entrance of dairy cows along this side of the building. Four window openings are clearly visible in the original barn wall but little sash remains. A cow door opening in bay three is visible but the door is gone and the opening is closed from the inside. There is evidence of a wood ramp at this door location. It is extremely deteriorated and almost entirely gone. The added three bays of the barn have three window openings at the first floor and three window openings at the cellar level. The barn follows the grade and drops down as the land slopes away towards the southwest. Clapboards exist all along the south eave wall and follow onto the connected silo ell which intersects the main barn at bay one. The granite stone foundation is visible along the entire length of the south eave and retaining walls extend perpendicular to the foundation. The grade is high and there is a clear drip line swale along the length of the wall due to roof water run off.

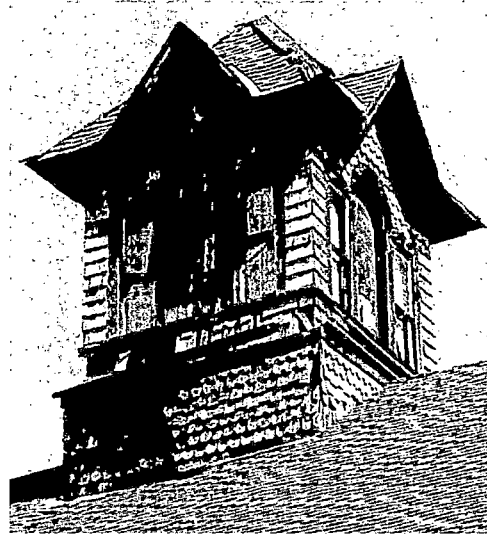
The Cupola

The cupola on top of the original barn is in significant structural failure. It should be stabilized and removed to the ground in order to reduce the risk of continued damage to its architectural and structural elements. The extent of damage here also poses a significant safety risk should strong wind and heavy snow aid in its imminent collapse. The cupola is the one element of the barn that is highly decorated. Upon placing the structure on the ground, it should be sheltered inside the cellar bay at the rear of the barn or covered by a temporary structure that will protect and secure it. The remaining roof opening atop the barn must be covered with a temporary roof designed to prevent continued water penetration into the structure. (The Benson's Committee has suggested that the cupola be removed to the Hudson Highway Maintenance Facility pending restoration and re-erection).

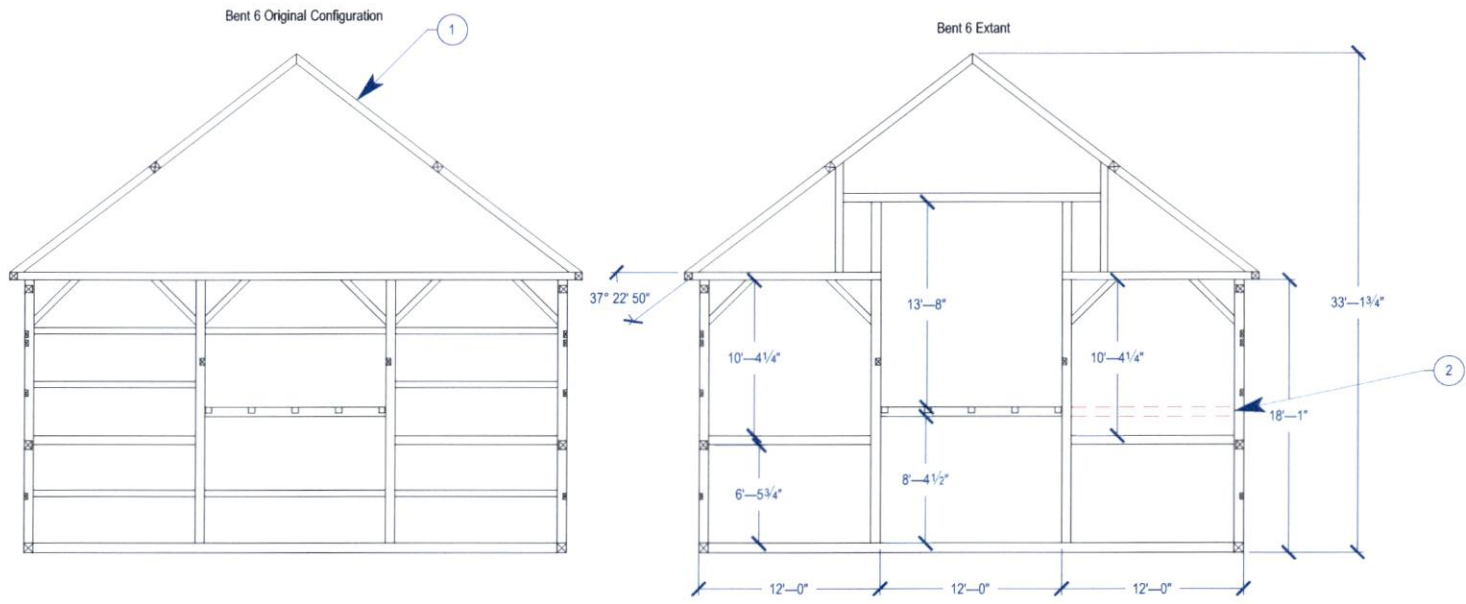
HASELTON BARN HUDSON, NH	
Bent 6 Elevation Viewpoint from the East (non-layout/reference face)	
SCALE: 1/8" = 1'	SHEET # 5 of 18
DRAWN BY: J. Butler	DATE 5/18/03
PRESERVATION TIMBER FRAMING INC. POST OFFICE BOX 29, ELIOT, MAINE 03903 207 361-2091

1. Bent 6 underwent significant modification when the phase 2 barn was added to the phase 1 barn. The original configuration of bent 6 appears on the left. Original gable framing is not entirely understood.
2. Present Drive Bay floor level on the North side of the barn.

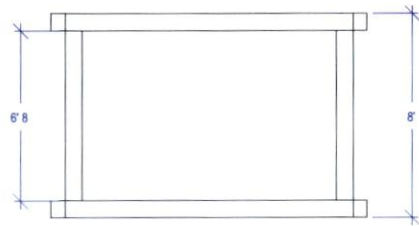
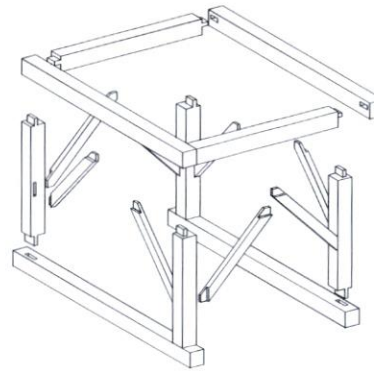
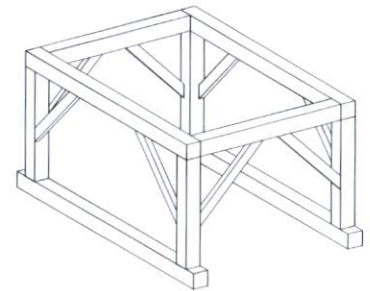
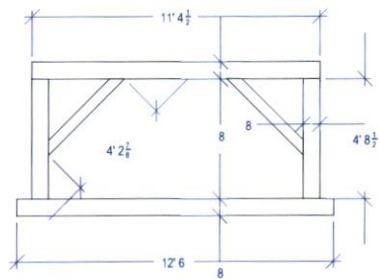
HASELTON BARN Hudson, New Hampshire	
Cupola Support Base Elevation, Plan and Axonometric	
SCALE: No Scale	SHEET # 15 of 18
DRAWN BY: J. Butler	DATE: 5/15/03
PRESERVATION TIMBER FRAMING INC. POST OFFICE BOX 29, ELIOT, MAINE 03903 207 361-2091

The cupola is in great jeopardy. It is almost in complete structural failure and currently leaks at every corner. A considerable number of lower structural elements have rotted away leaving the lower sheathing hanging from poor fasteners.

The original structural support for the cupola is inadequate and must be revised. To accomplish this two sleeper beams will be placed across the high tie beams in bents three and four parallel to the drive. These sleepers will measure 8"x 8" square and cog over the tie beam. The sleeper beams run parallel with the center drive directly below the cupola framing. Once in place, a short post at each corner will be placed and a top plate will be installed to make a box frame on top of the posts. The posts should be braced with mortise and tenoned angle braces both ascending to the plate level and descending to the sleeper beams. Posts will be mortised and tenoned into the sleeper beams and posts. Once in place the cupola can be flown into position and the new cupola framing will be mortise and tenoned into the plate and the exterior sheathing fastened into the plate as well. This provides ample support for the weight of the cupola while providing a sufficient base to which proper flashing can be applied. The cupola stairs and platforms can then be reinstalled to allow access to the cupola for maintenance.

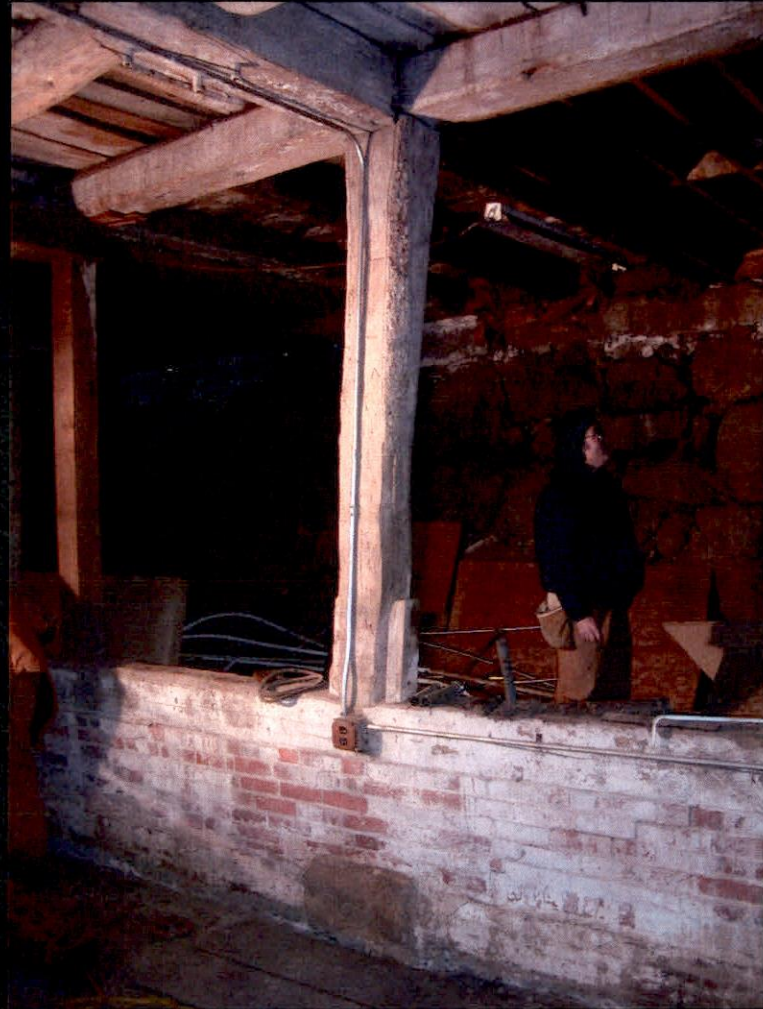
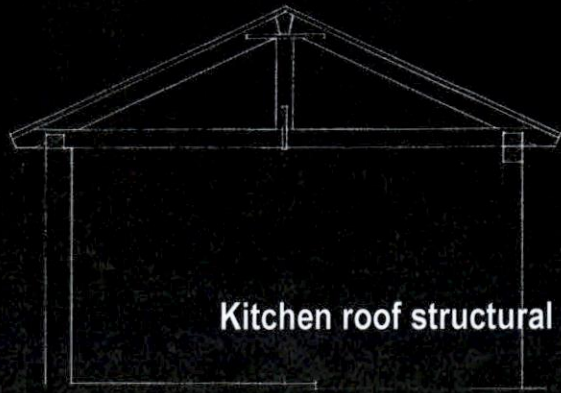
Kitchen roof structural layout

The east elevation of the Kitchen opened originally into the now demolished restaurant area. The existing dropped ceiling and center partitions were later additions, probably constructed during Arthur Provencher's ownership. The original roof structure of recycled hand-hewn timber beams and king-post trusses was designed to be visible. The design element seen in the roof framing was continued in the braced timber posts framing the opening. These have been removed and replaced with a steel "I" beam and pipe column.

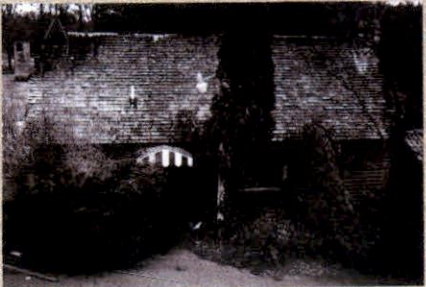
Structure Name: Benson's Office Feature Name: Wood shingle roof

Feature Description:
 The roof of the Benson's Office is covered with cedar shingles at 5-1/2" exposure. Wood shingles are original to the construction of the Office. It has not been determined if this is the original roof. The wood shingled roof contributes significantly to the architectural character of the Office, and should be replaced in-kind.

Quantity: 12 Measure unit: SQ Condition Rating: Poor

Feature Condition:
 The roof covering is nearing the end of its useful life. Although there is not any evidence of active leaks, the roof service has suffered mechanical damage and ultraviolet breakdown. There are areas of cracked, missing, and broken shingles. Much of the ridge is missing or damaged.

Treatment Type: Rehabilitation Priority: High Def Quantity: 12 Unit Cost: \$436.00 Measure unit: SQ Repair/Replacement Cost: \$5,232.00
