## Historic Structures Report

Benson's Property  
Town of Hudson, New Hampshire  
June 16, 2003 – 100% Submittal

## Benson's Office and Kitchen

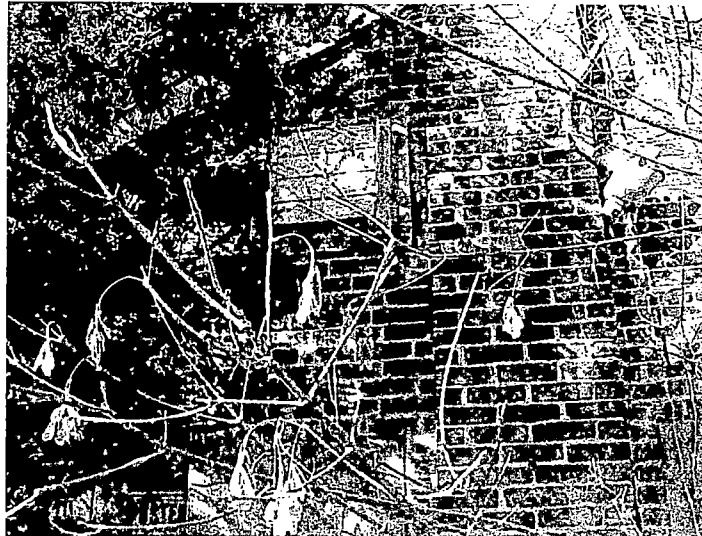
*Exterior: Brick Chimney*

The 24" square brick chimney is centered on the ridge line of the gable roof, and extends 12 courses above the low point of the roof line.
